Technical Memorandum

Subject: Benton County Ditch 9 Repair Report

Date: March 28, 2023

Project: 6183-0005

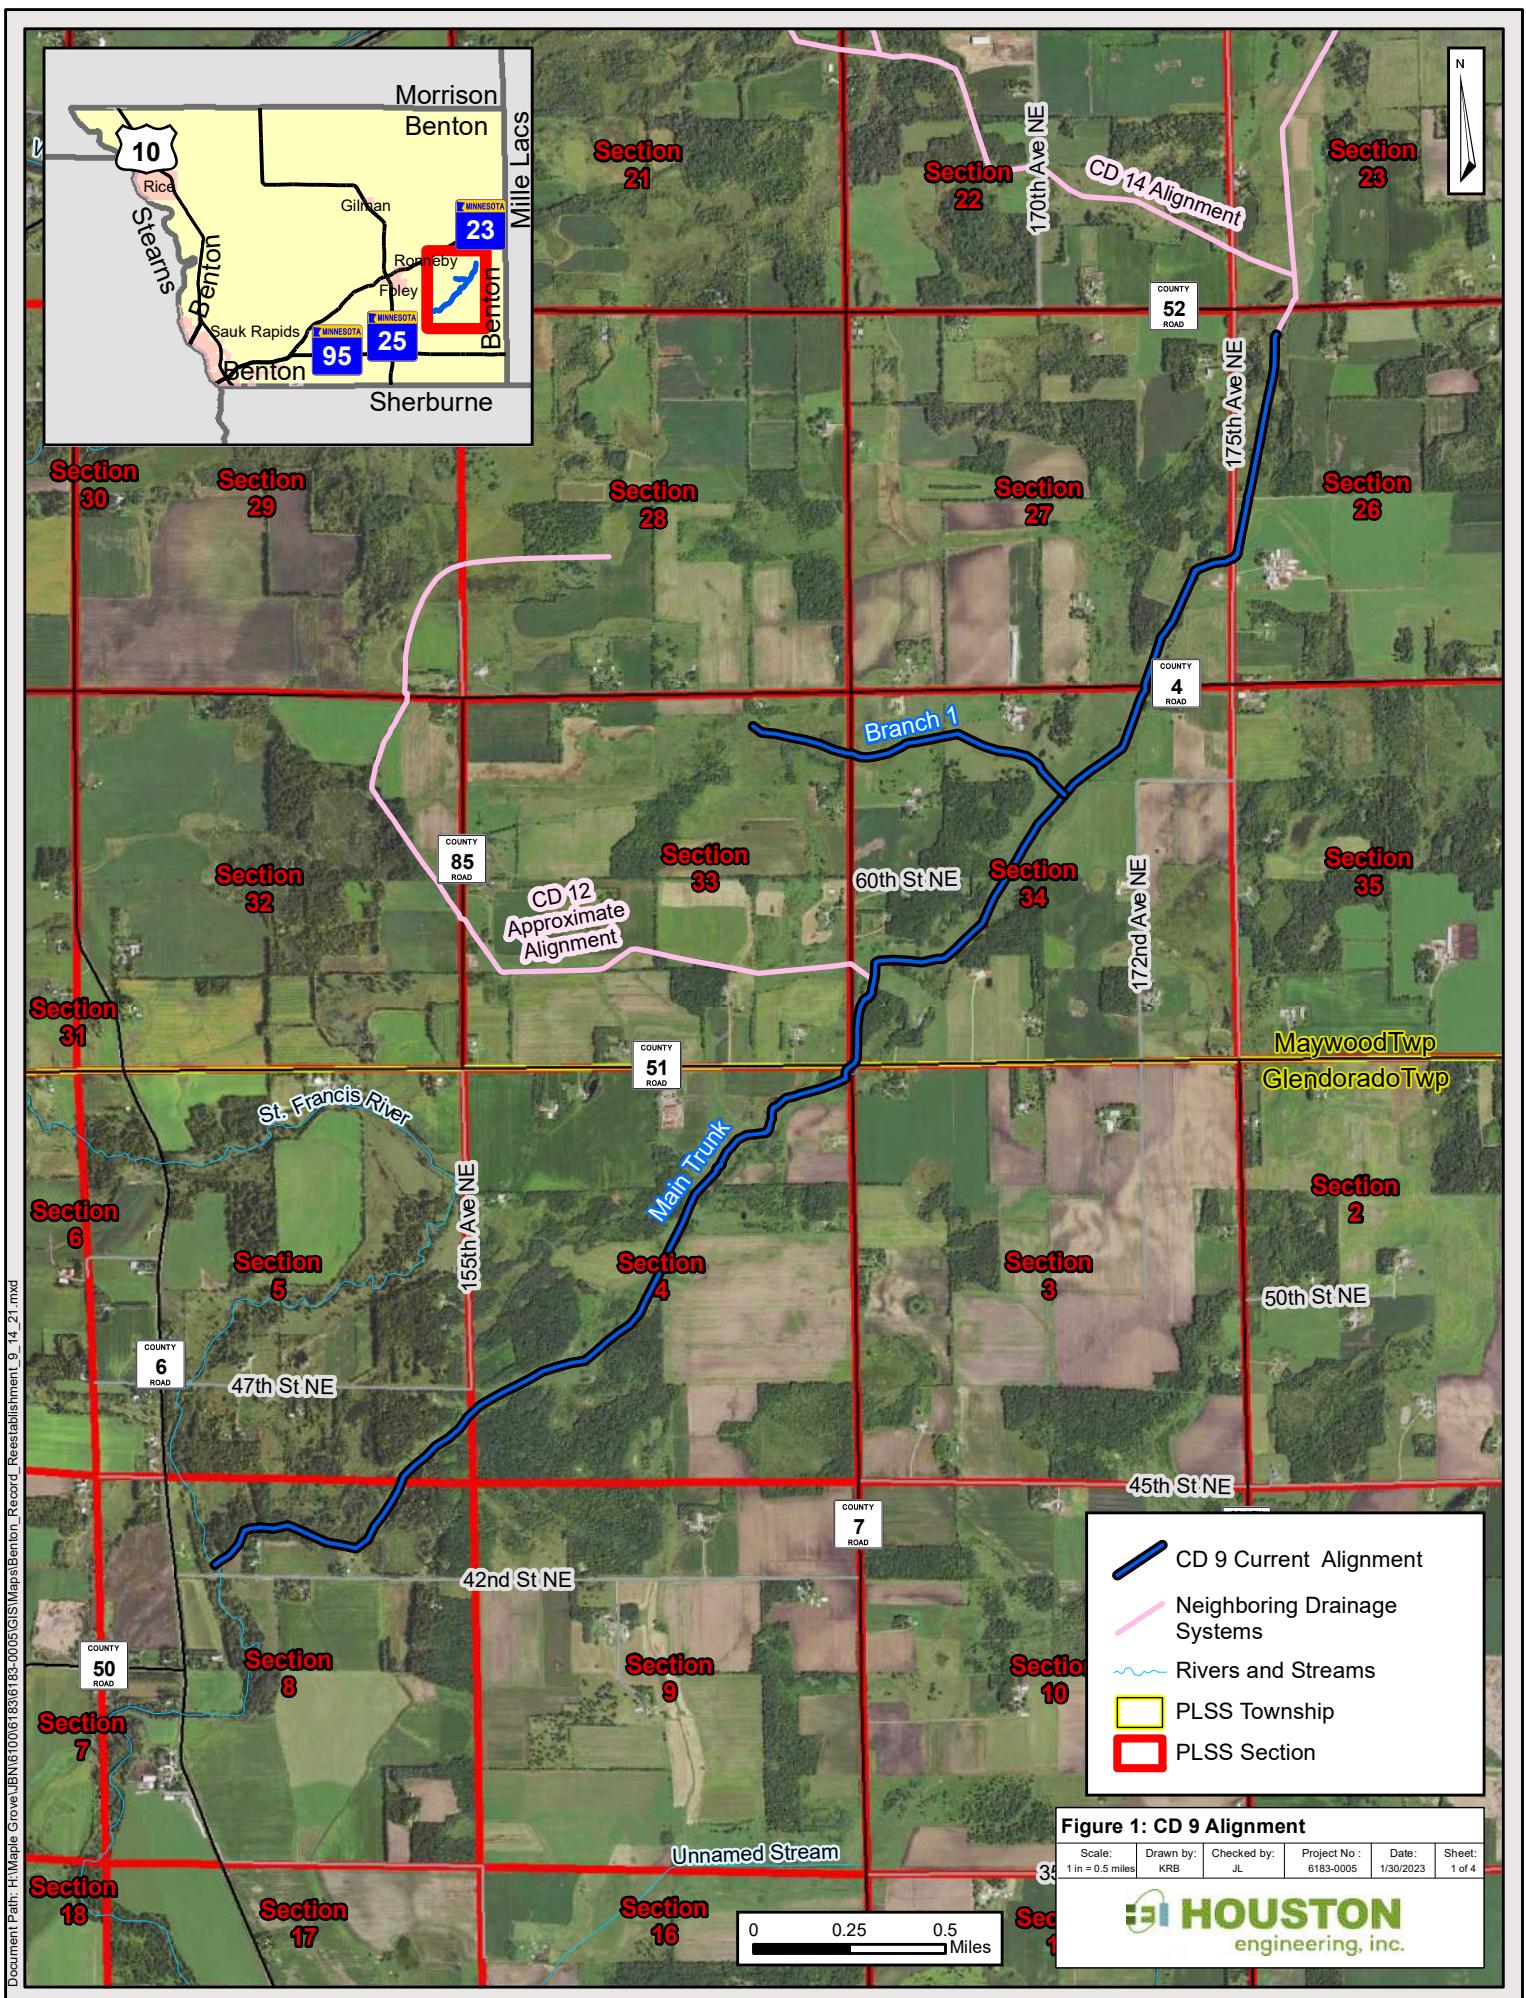
Benton County Ditch 9 (CD 9), shown in **Figure 1**, is a 5.6-mile ditch system that consists of a 4.7-mile Main Trunk and a 0.9-mile Branch 1. The system is located within Sections 26, 27, 33 and 34 of Maywood Township (T37N R28W) and Sections 4, 5 and 8 of Glendorado Township (T36N R28W) in Benton County.

The Main Trunk flows northeast to southwest from 300 feet south of 75th Street NE to 100 feet north of 42nd Street NE, a distance of 4.7 miles, where it drains into the St Francis River. Branch 1 flows west to east from 700 feet west of 165th Avenue NE to its confluence with the Main Branch 750 feet west of the 62nd Street and 172nd Avenue NE intersection. The system consists entirely of open channel ditch sections. Benton County Ditch 14 (CD 14) outlets into CD 9 at the upstream starting point. Benton County Ditch 12 (CD 12) also outlets into CD 9 near the midpoint of the CD 9 Main Trunk.

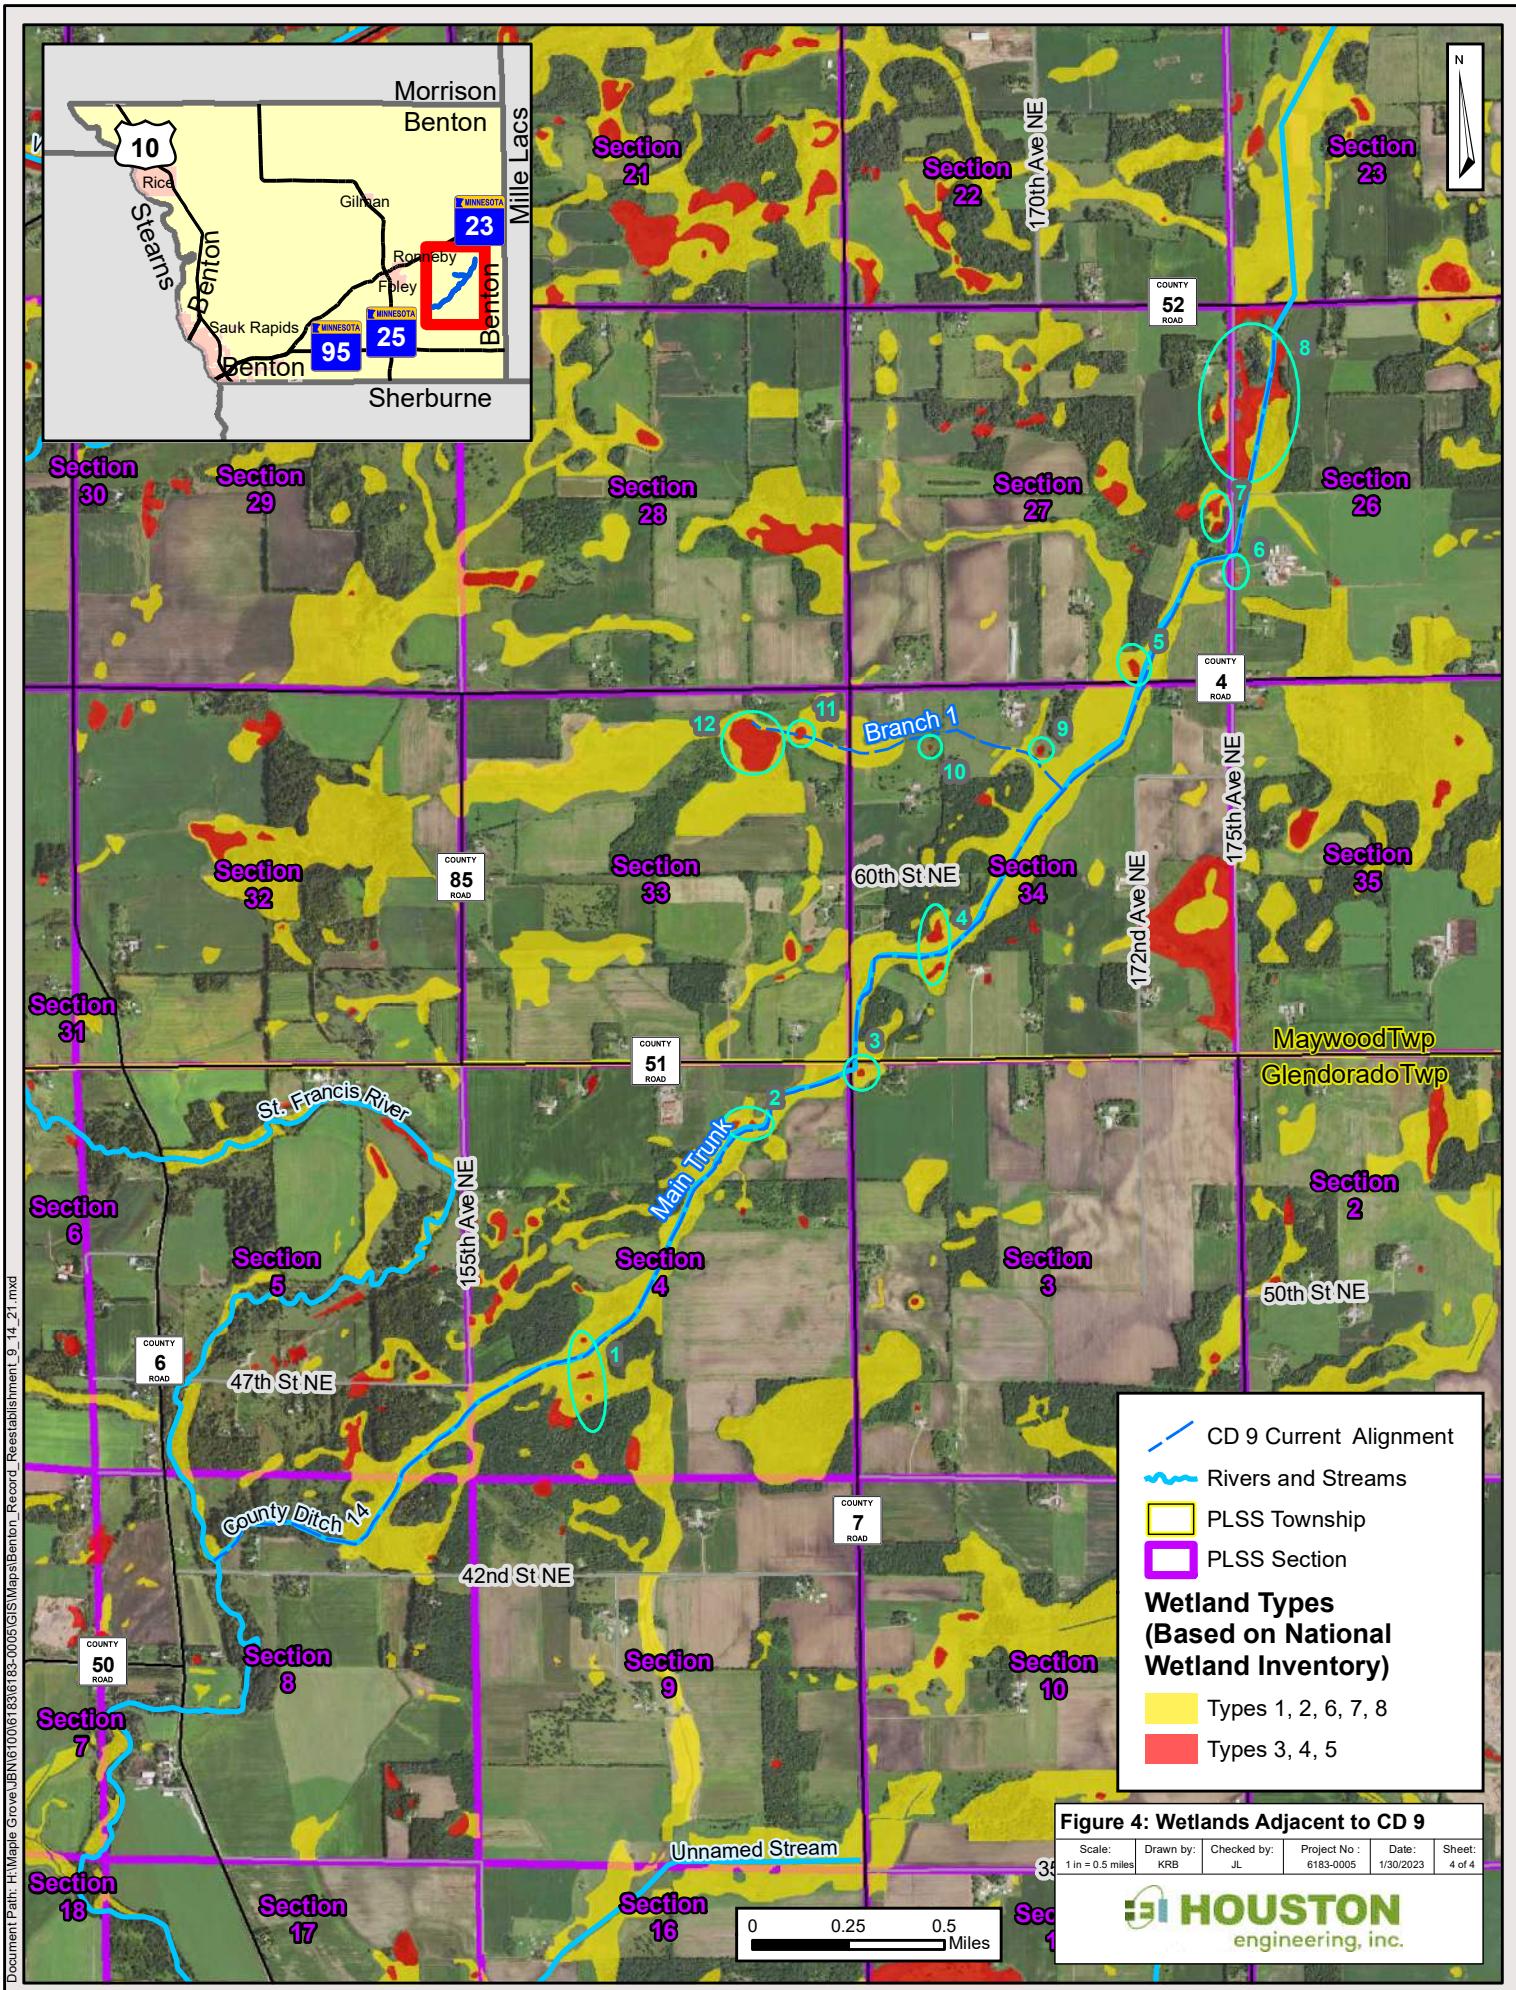
As seen in **Figure 4** CD 9 does not intersect any state-listed Public Waters or Public Water Wetlands (PWI). The main trunk of CD 9 channel is listed as a Public Watercourse but is categorized as a “Public Ditch / Altered Natural Watercourse”, which does not typically require any Public Waters permitting coordination with the MnDNR. Lateral 1 is not listed as a PWI or a Public Ditch / Altered Natural Watercourse.

The results from the field survey indicate that the corridor includes a total of approximately 297 acres of wetland, of which 15.2 acres is classified as a Type 3, 4 or 5 wetland. See **Figure 4** or the results of the field investigation.

Based on a review of the NWI data and field inventory work to confirm wetland types, there are eight locations on the main trunk and four locations on Lateral 1 of CD 9 where Type 3, 4, and 5 wetlands are present (**Figure 4**). **Table 5** provides a description of these sites and specifies locations where alternative repair work could be implemented to reduce potential wetland impacts. Three locations have the potential for impacts to Type 3, 4, and 5 wetlands if the repair work is implemented to the ACSIC. As such, the drainage system repair project may not meet the exemption criteria of the state WCA for all wetlands near the proposed repairs. Repair Alternative 2 (partial repair) has been developed to provide restoration of drainage while minimizing potential wetland impacts. Based on this review of the wetland locations and the depth of accumulated sediment above the ACSIC profile, we estimate approximately 3.6 acres of potential wetland impacts requiring mitigation under Alternative 1.
