Technical Memorandum

Subject: Benton County Ditch 14 Repair Report

Date: March 28, 2023

Project: 6183-0003

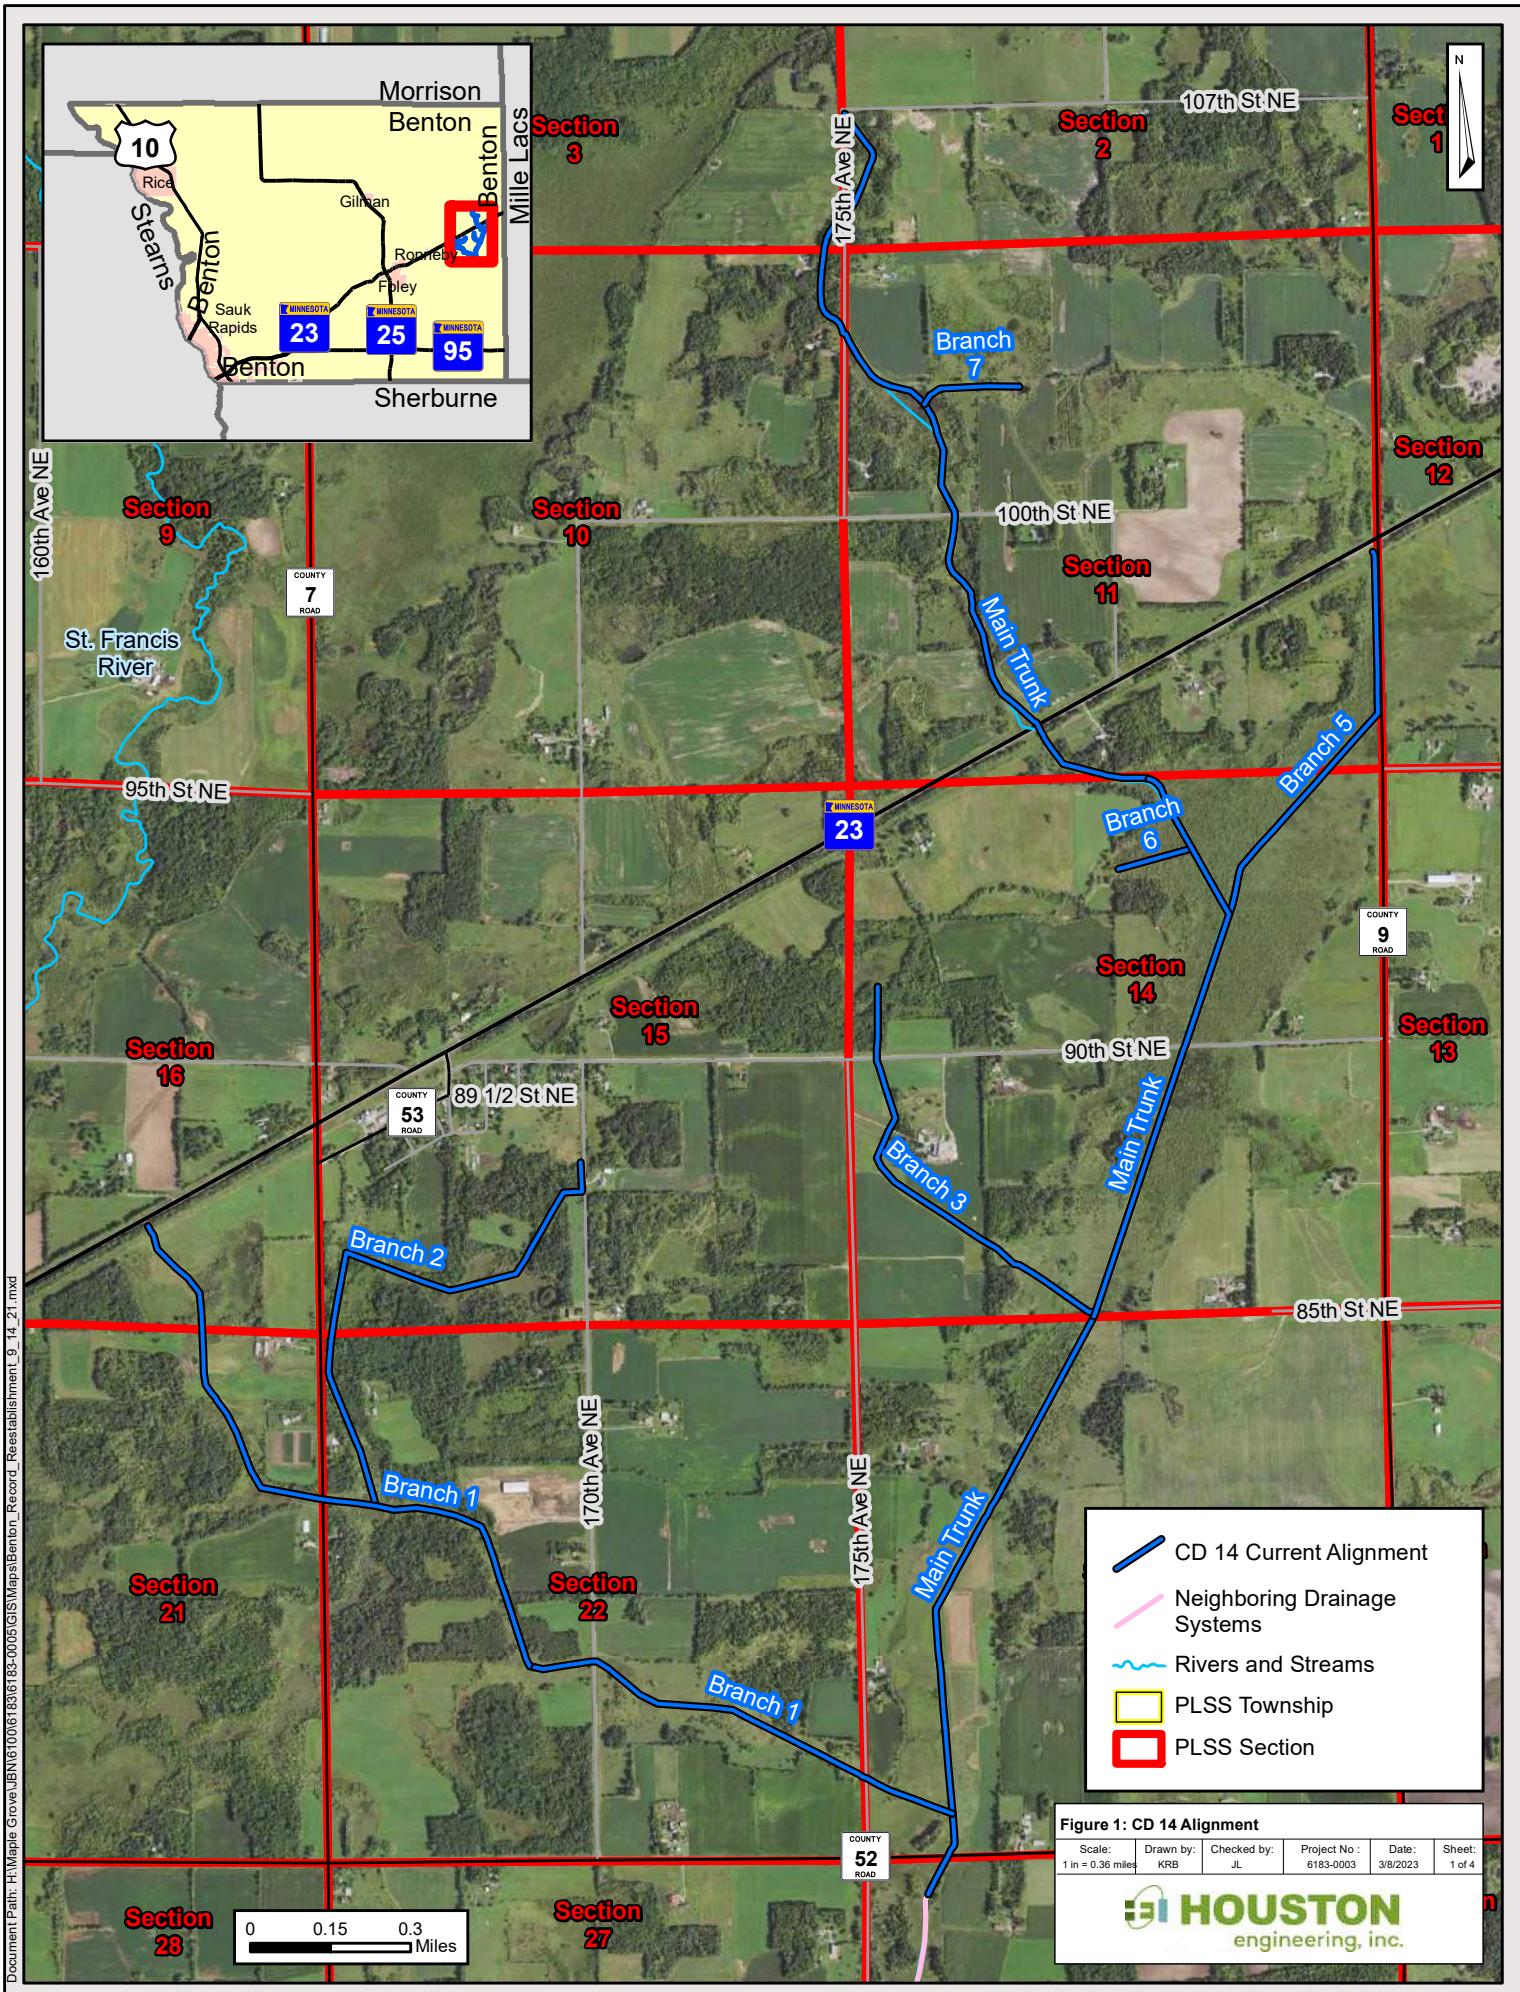
CD 14, shown in **Figure 1**, is 9.0-miles in length consisting of a 3.9-mile Main Trunk, 2.1-mile Branch 1, 1.1-mile Branch 2 tributary to Branch 1, 0.8-mile Branch 3, 0.8-mile Branch 5, 0.1-mile Branch 6, and 0.2-mile Branch 7. The system is located southeast of Oak Park in Sections 2, 3, 10, 11, 14, 15, 16, 21, 22, 23, and 26 of Maywood Township (T37N, R28W) in Benton County.

The Main Trunk flows north to south from 107th Street NE to 400 feet south of CR 52 where it drains into CD 9. Branch 1 flows west to east from MN-23 to its confluence with the Main Branch near CR 52. Branch 2 flows generally south from 170th Avenue NE near Oak Park before draining into Branch 1 near CR 7. Branch 3 flows southeast from 700 feet north of 90th Street NE before draining into the Main Trunk near 85th Street. Branch 5 flows southwest from MN 23 before draining into the Main Trunk north of 90th Street NE. Branch 6 flows east for 750 feet before draining into the Main Trunk in Section 14. Branch 7 flows west for 1,000 feet before draining into the Main Trunk near 175th Avenue NE. The system consists entirely of open ditch sections.

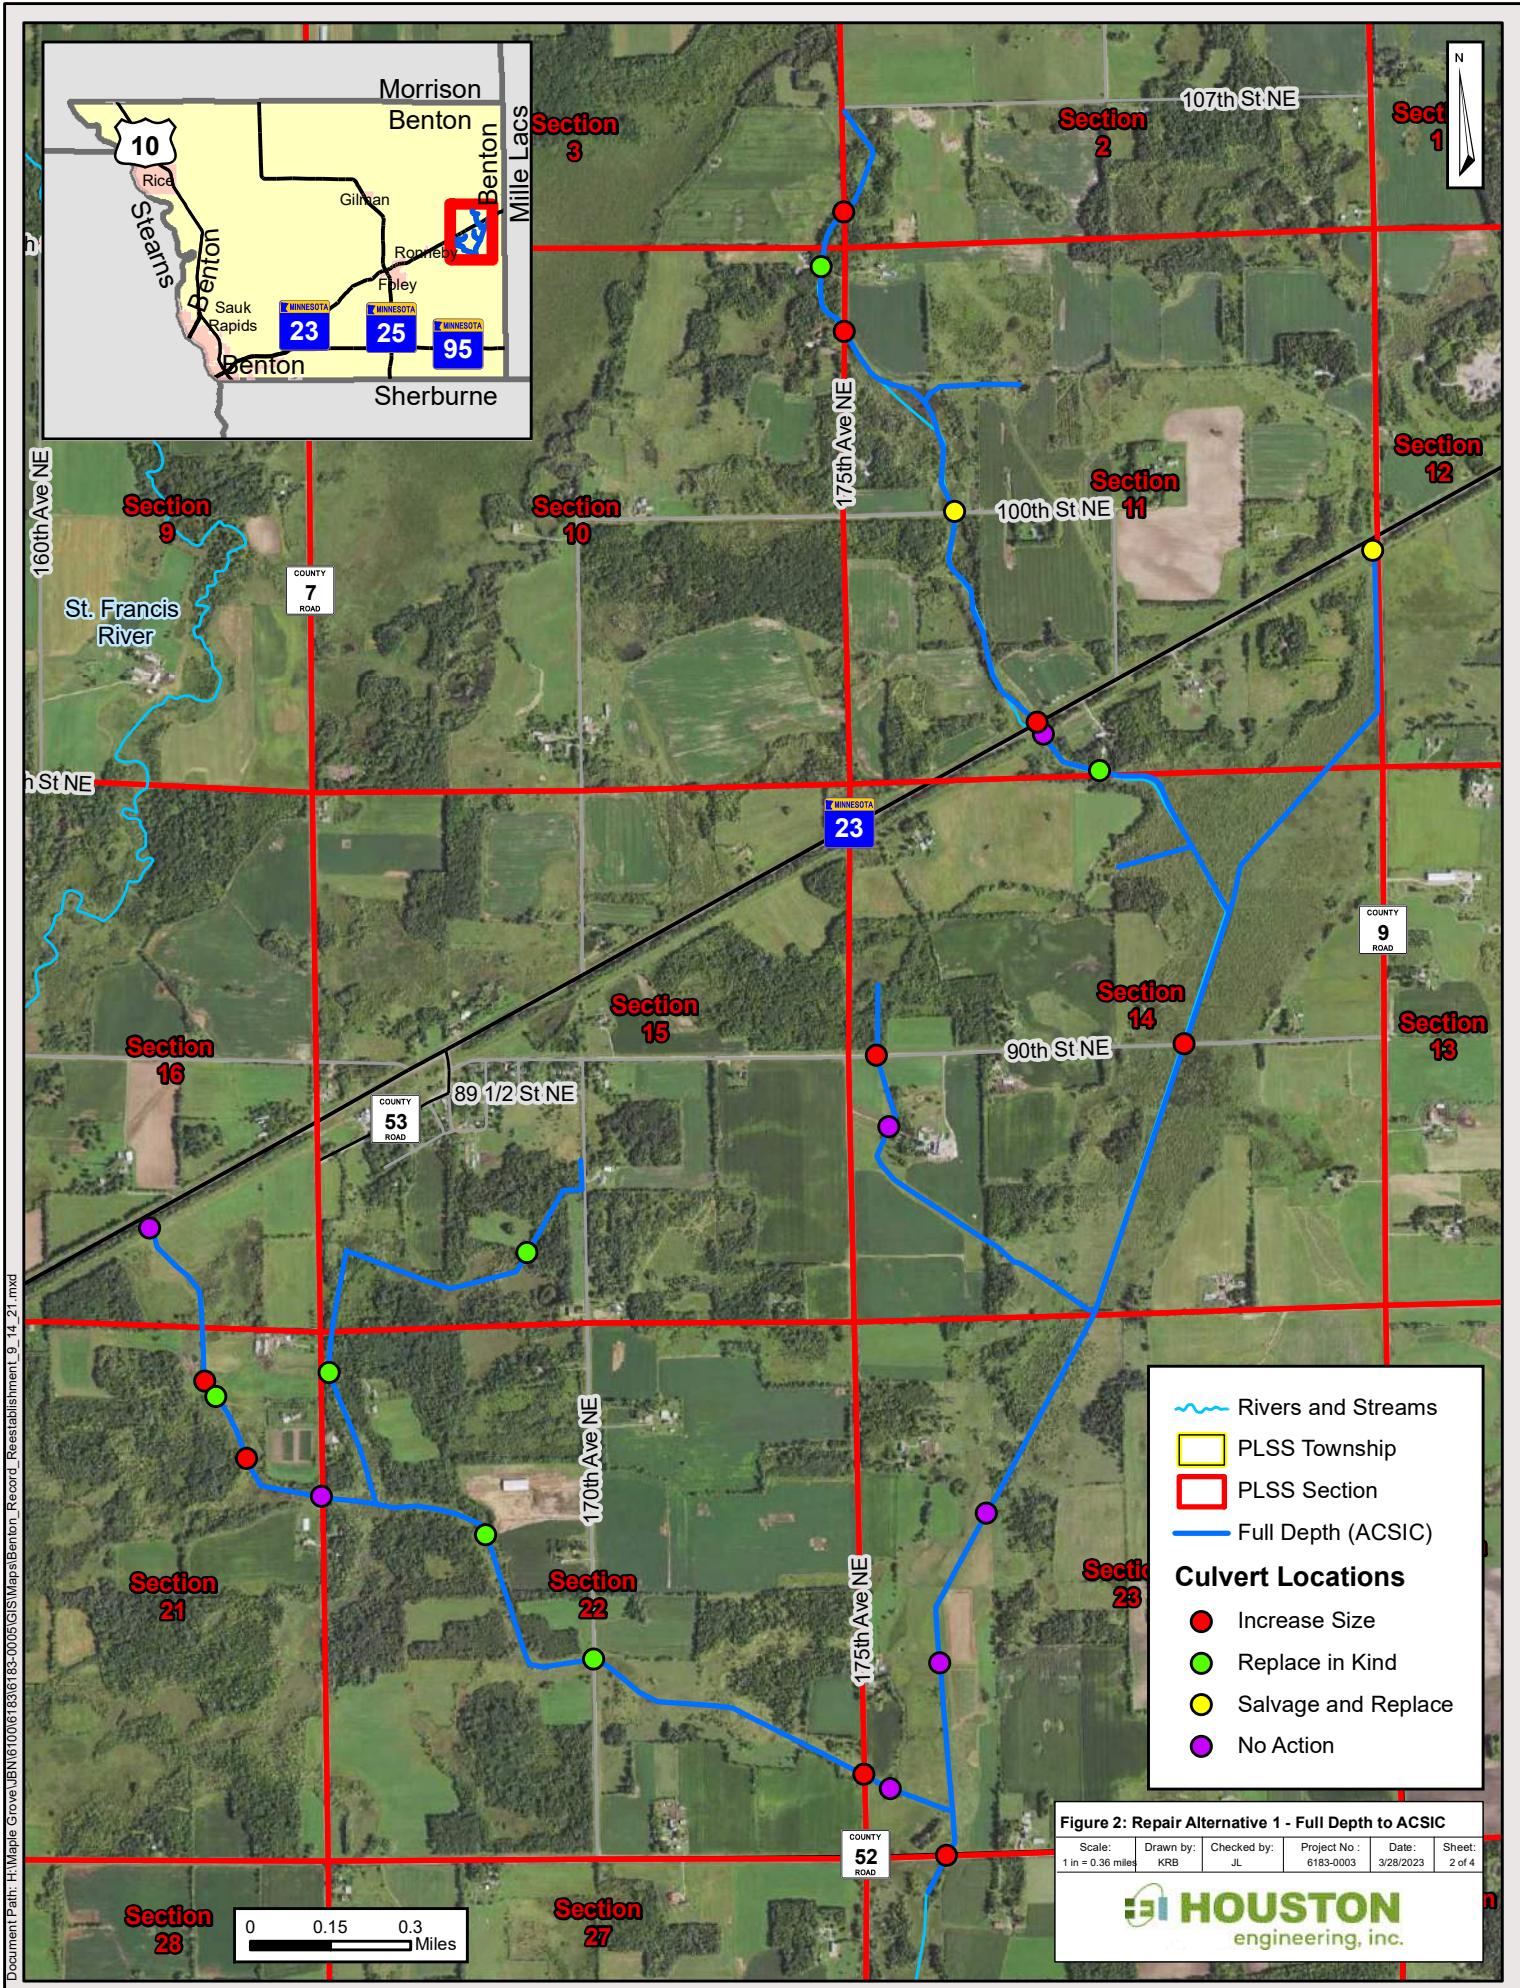
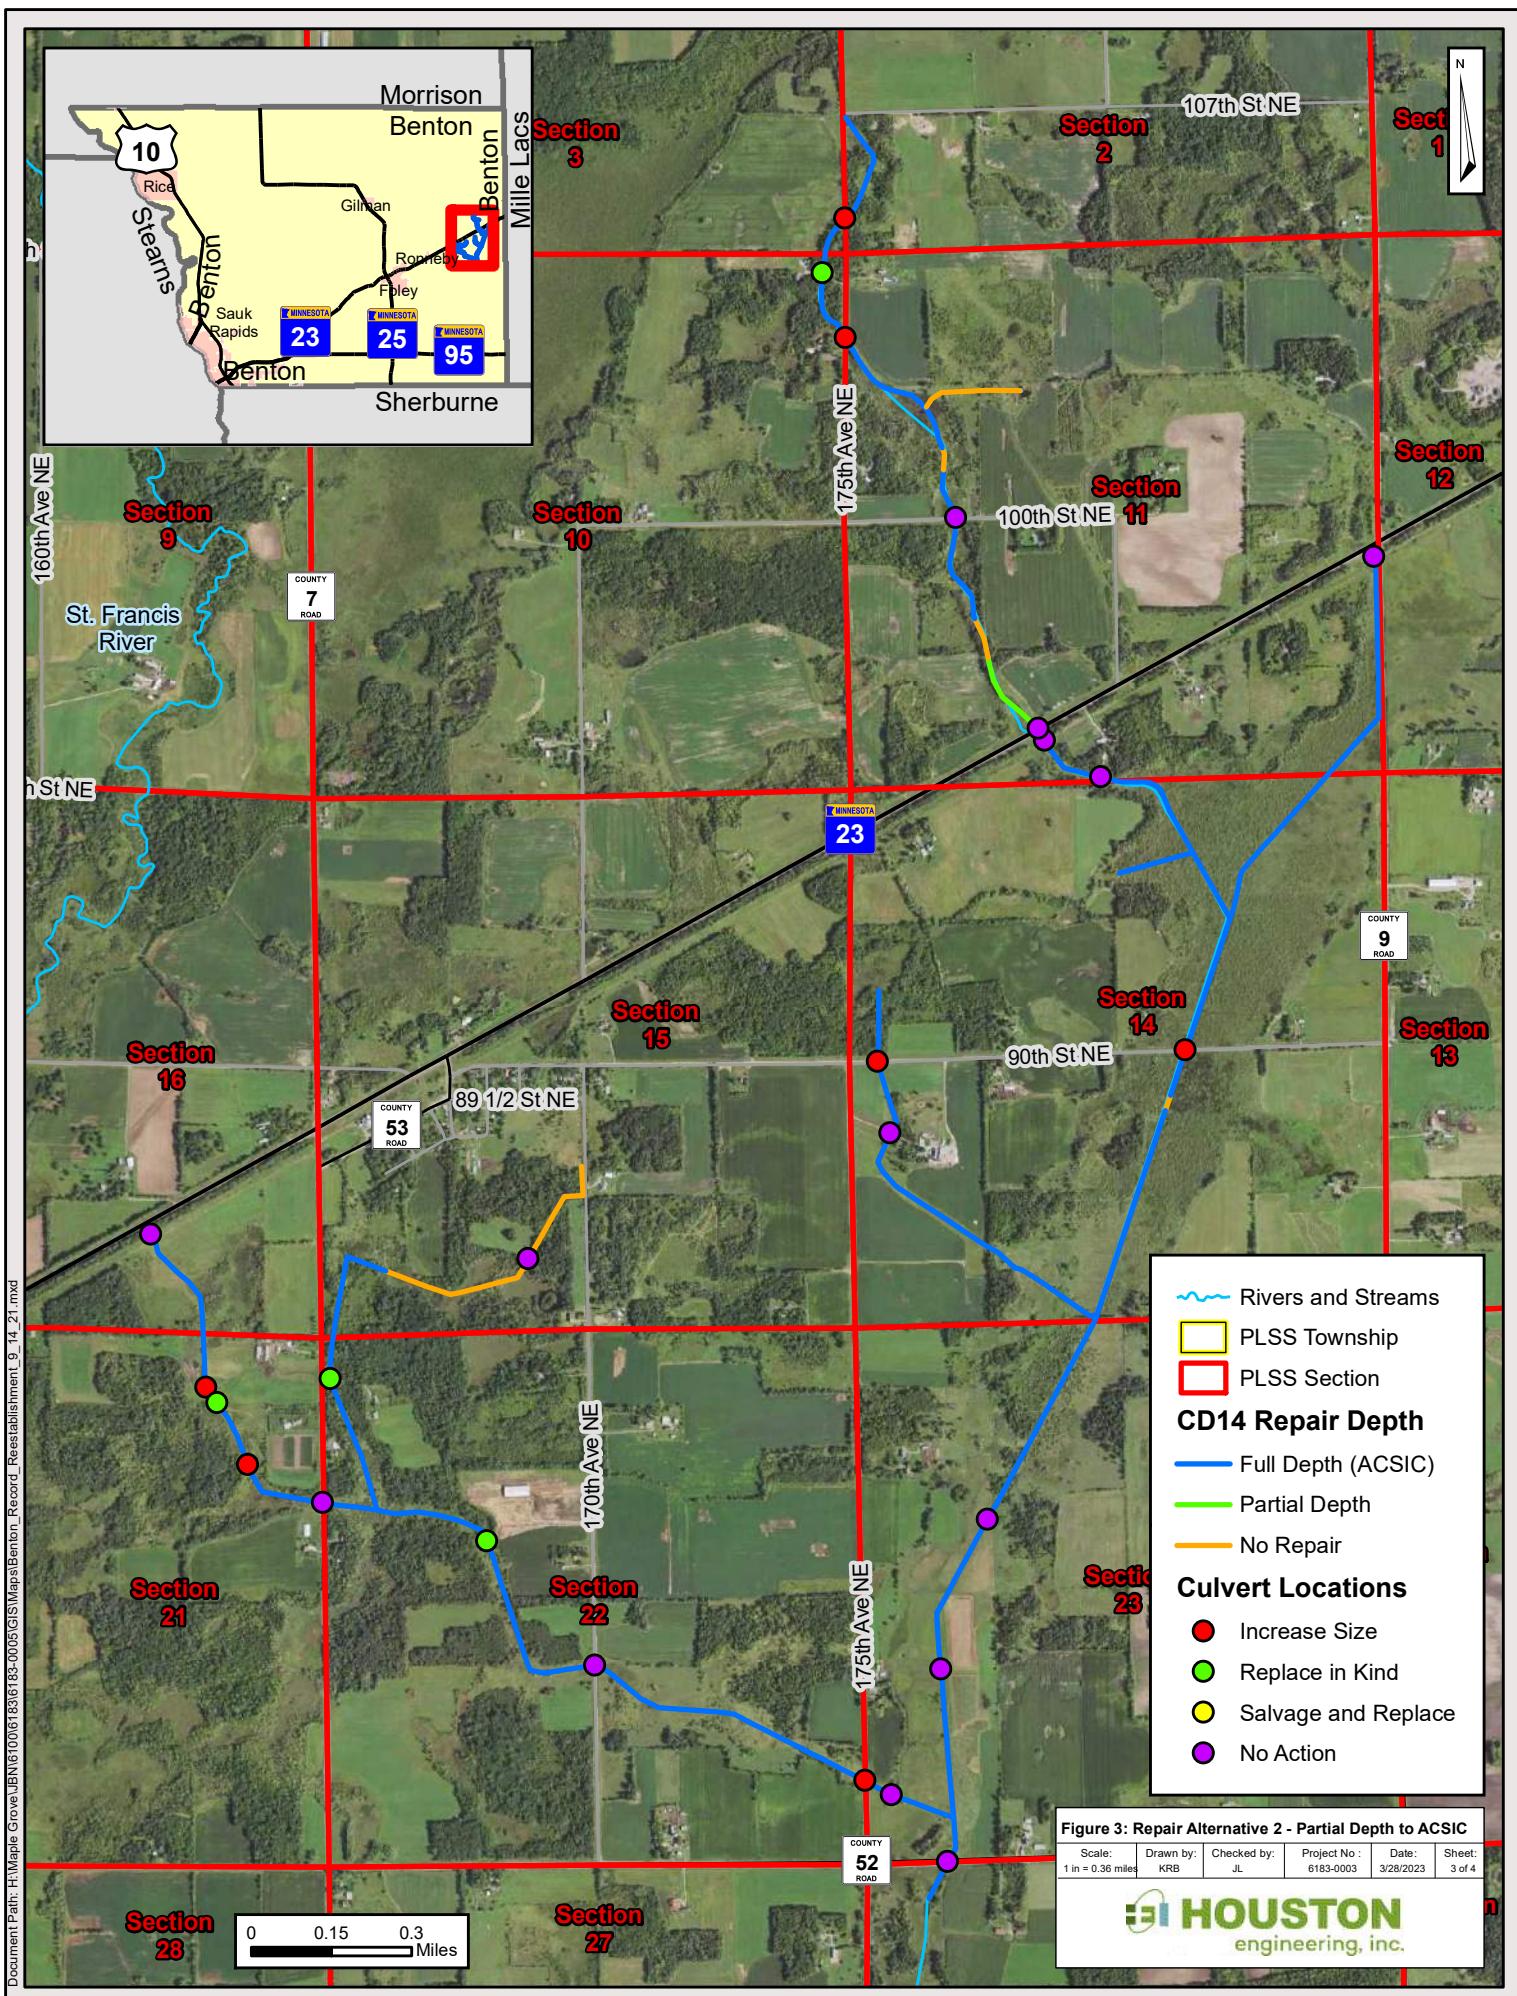
A total of 25 crossings are located along the CD 14 alignment, and 18 and 11 are recommended for replacement in Alternatives 1 and 2, respectively. Ten of the existing crossings are located at public roadways, and of those, 9 and 5 are recommended for replacement in Alternatives 1 and 2, respectively. **Table 2** lists the CD 14 culverts and the proposed replacement actions, culvert sizes, and materials for both Alternative 1 and 2. **Figure 2** and **Figure 3** shows the locations of CD 14 culverts and the proposed repair actions.

- Is the current culvert invert significantly above the ACSIC elevation? If yes, then the culvert is recommended to be replaced unless there is significant grade in the upstream ditch profile which limits the potential drainage impairment for upstream property owners.
- Does the culvert have adequate capacity to pass the design flow without road overtopping (for public roadways) or without overtopping the ditch banks for field crossings?
 - If a field crossing is undersized based on the drainage design criteria (2-year event design), a larger culvert is recommended to meet the design criteria.
 - If a Township road crossing is undersized based on road sizing criteria (10-year event) a replacement is recommended to meet the 10-year event.
 - If a County road crossing is undersized based on road sizing criteria (50-year event) a replacement is recommended to meet the 50-year event.

The CR 52 culvert over the Main Trunk is not shown as recommended for replacement in Alternative 2 although it doesn't meet the design criteria listed above. The existing culvert has a limited amount of cover over the pipe leading to overtopping during the 25- and 50-year events. If the culvert is replaced by the Highway Department, its likely that a grade raise of the roadway would be considered which would alter the hydraulic analysis of the crossing. The current CR 52 culvert passes the drainage design flow and generally matches the capacity of upstream and downstream crossings. Its recommended that the current culvert not be replaced as part of a drainage system repair project and that the Highway Department evaluate the need for modifying the crossing in the future.

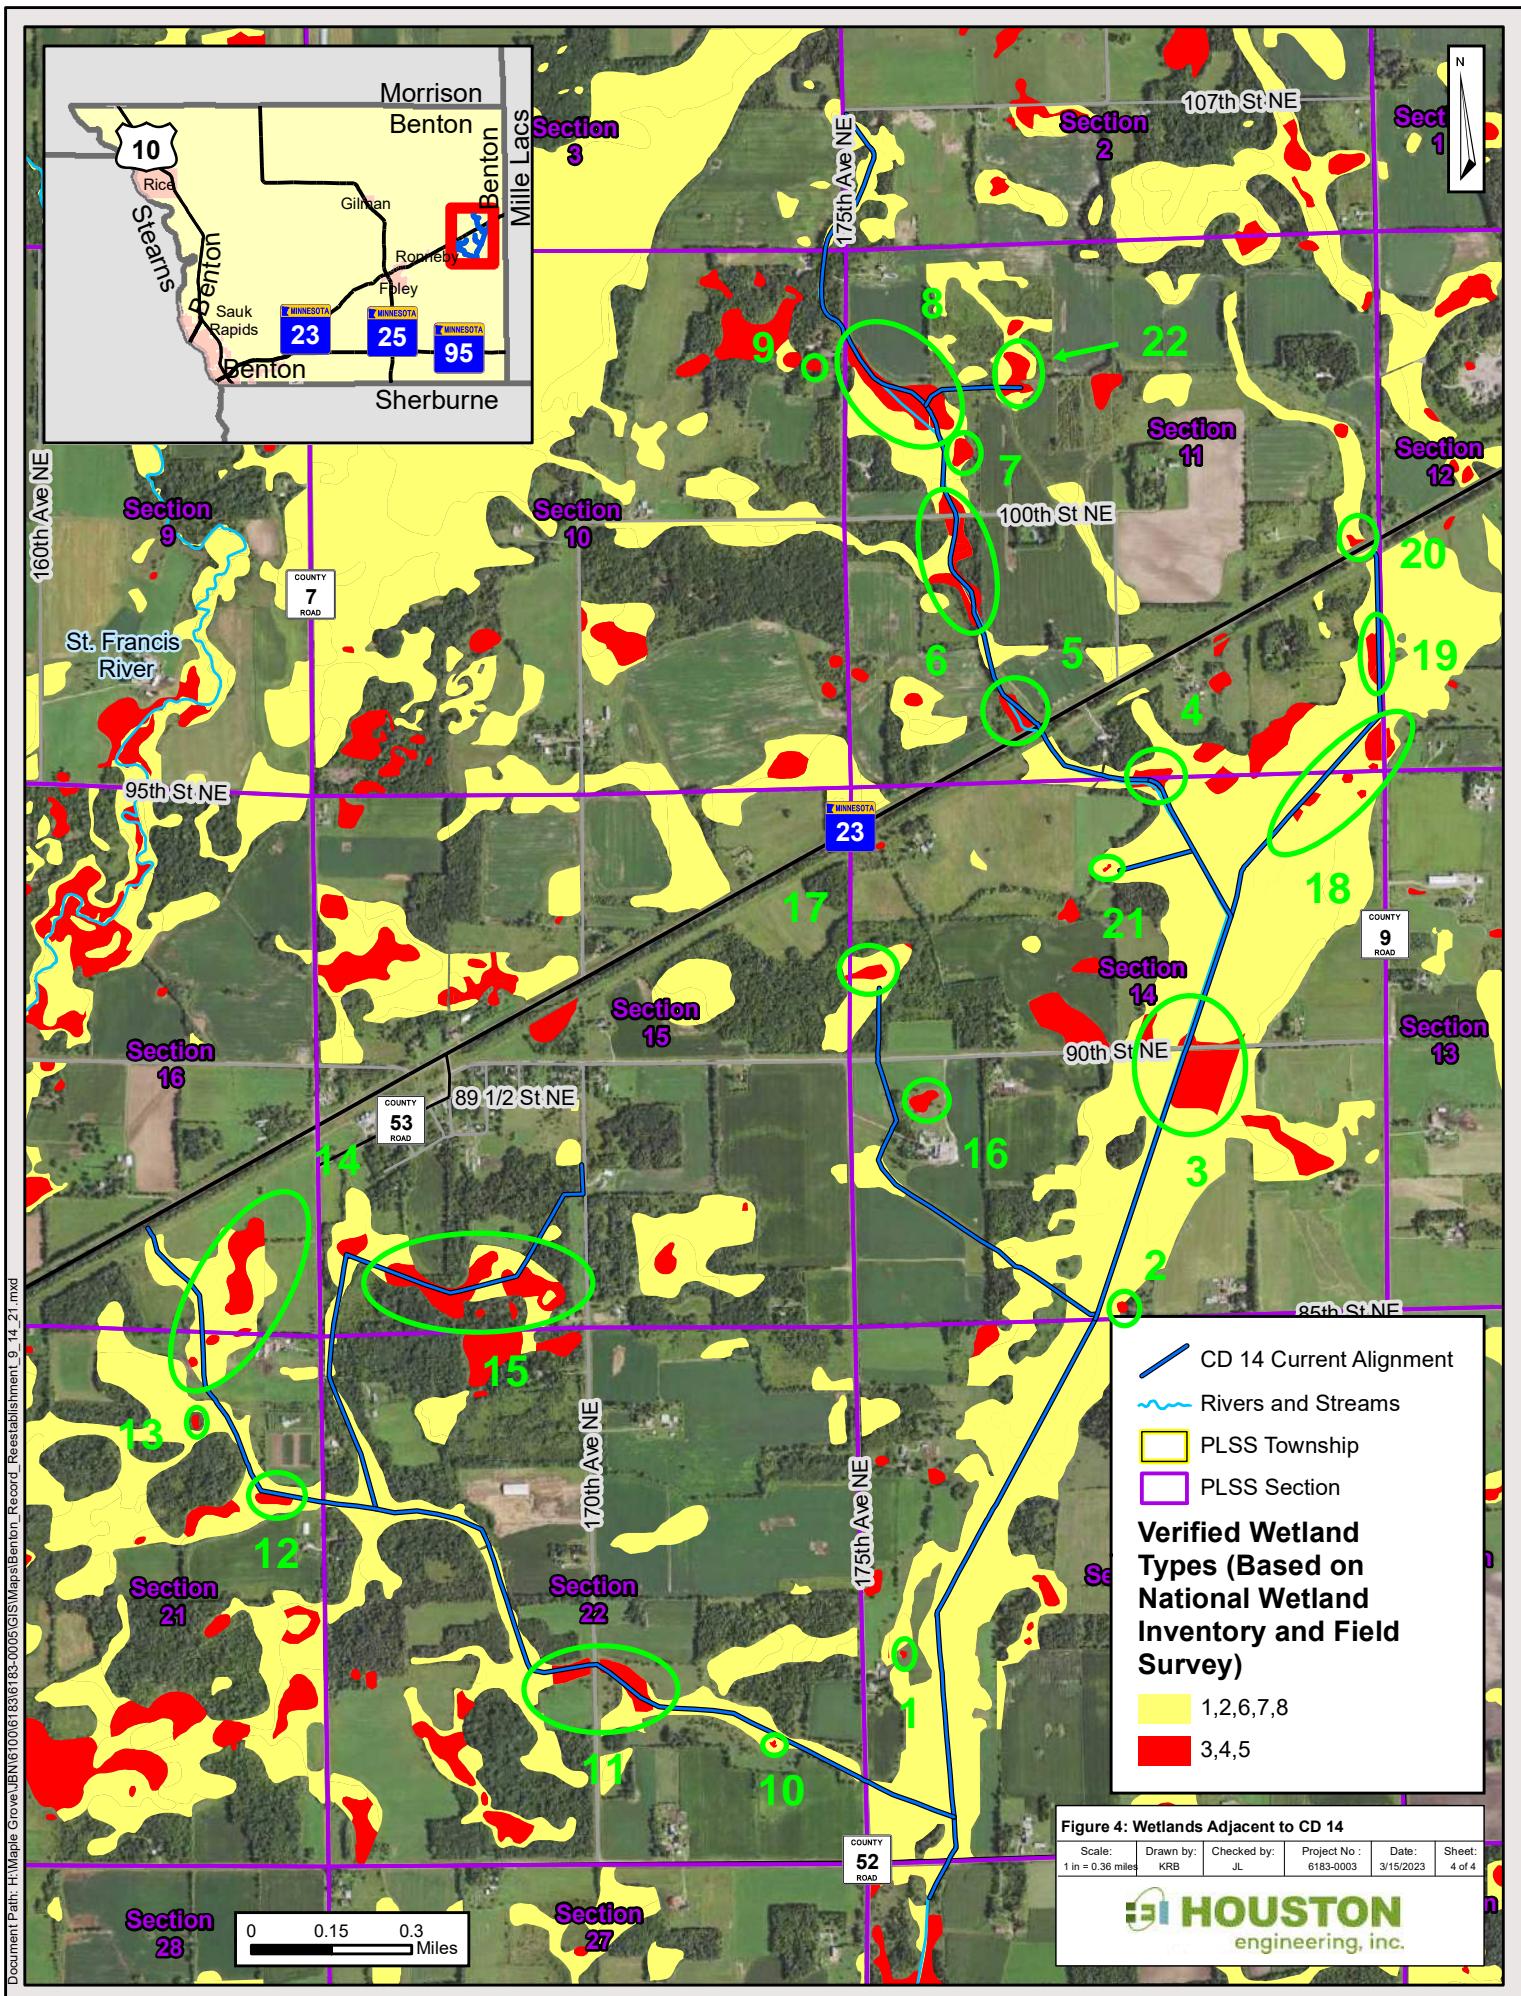
As seen in **Figure 4** CD 14 does not intersect any state-listed Public Waters or Public Water Wetlands (PWI). The main trunk of CD 14 channel is listed as a Public Watercourse but is categorized as a “Public Ditch / Altered Natural Watercourse”, which does not typically require any Public Waters permitting coordination with the MnDNR. Branches 1, 2, 3, 5, 6 and 7 are not listed as a PWI or a Public Ditch / Altered Natural Watercourse.

The CD 14 public drainage system intersects wetlands identified in the National Wetland Inventory (NWI) as shown in **Figure 4**. Under the two wetland regulatory programs, (Minnesota WCA and Federal CWA) activities related to repair of a public drainage system are generally exempt from permitting and mitigation requirements. These activities are related to public drainage system maintenance and repair, and include:

To verify the actual type and approximate extent of Type 3, 4 and 5 wetlands, HEI scientists visited the site on September 13th, 2022. Prior to visiting the site, the NWI and a series of years of aerial photography was reviewed to understand potential wetland types within the area. Once at the site, a 150-foot corridor was viewed. Using this field information, and the NWI as a baseline dataset, the NWI shapefiles were edited to incorporate the results of the field survey (as shown in **Figure 4**).

Based on a review of the NWI data and field inventory work to confirm wetland types, there are 22 locations on the ditch system where Type 3, 4, and 5 wetlands are present. **Table 3** provides a description of these sites and specifies locations where repair work has the potential for wetland impacts. Specifically, there are 7 locations on the system have the potential for impacts to Type 3, 4, and 5 wetlands if the repair work is implemented to the ACSIC. As such, the drainage system repair project may not meet the exemption criteria of the state WCA for all wetlands near the proposed repairs. Recommendations are provided in **Table 3** that indicate where repair work should vary from the ACSIC to minimize potential wetland impacts.
