# Technical Memorandum

**Subject:** Reestablishment of Benton County Ditch 6 Public Drainage System Records

**Project:** 6183-0001

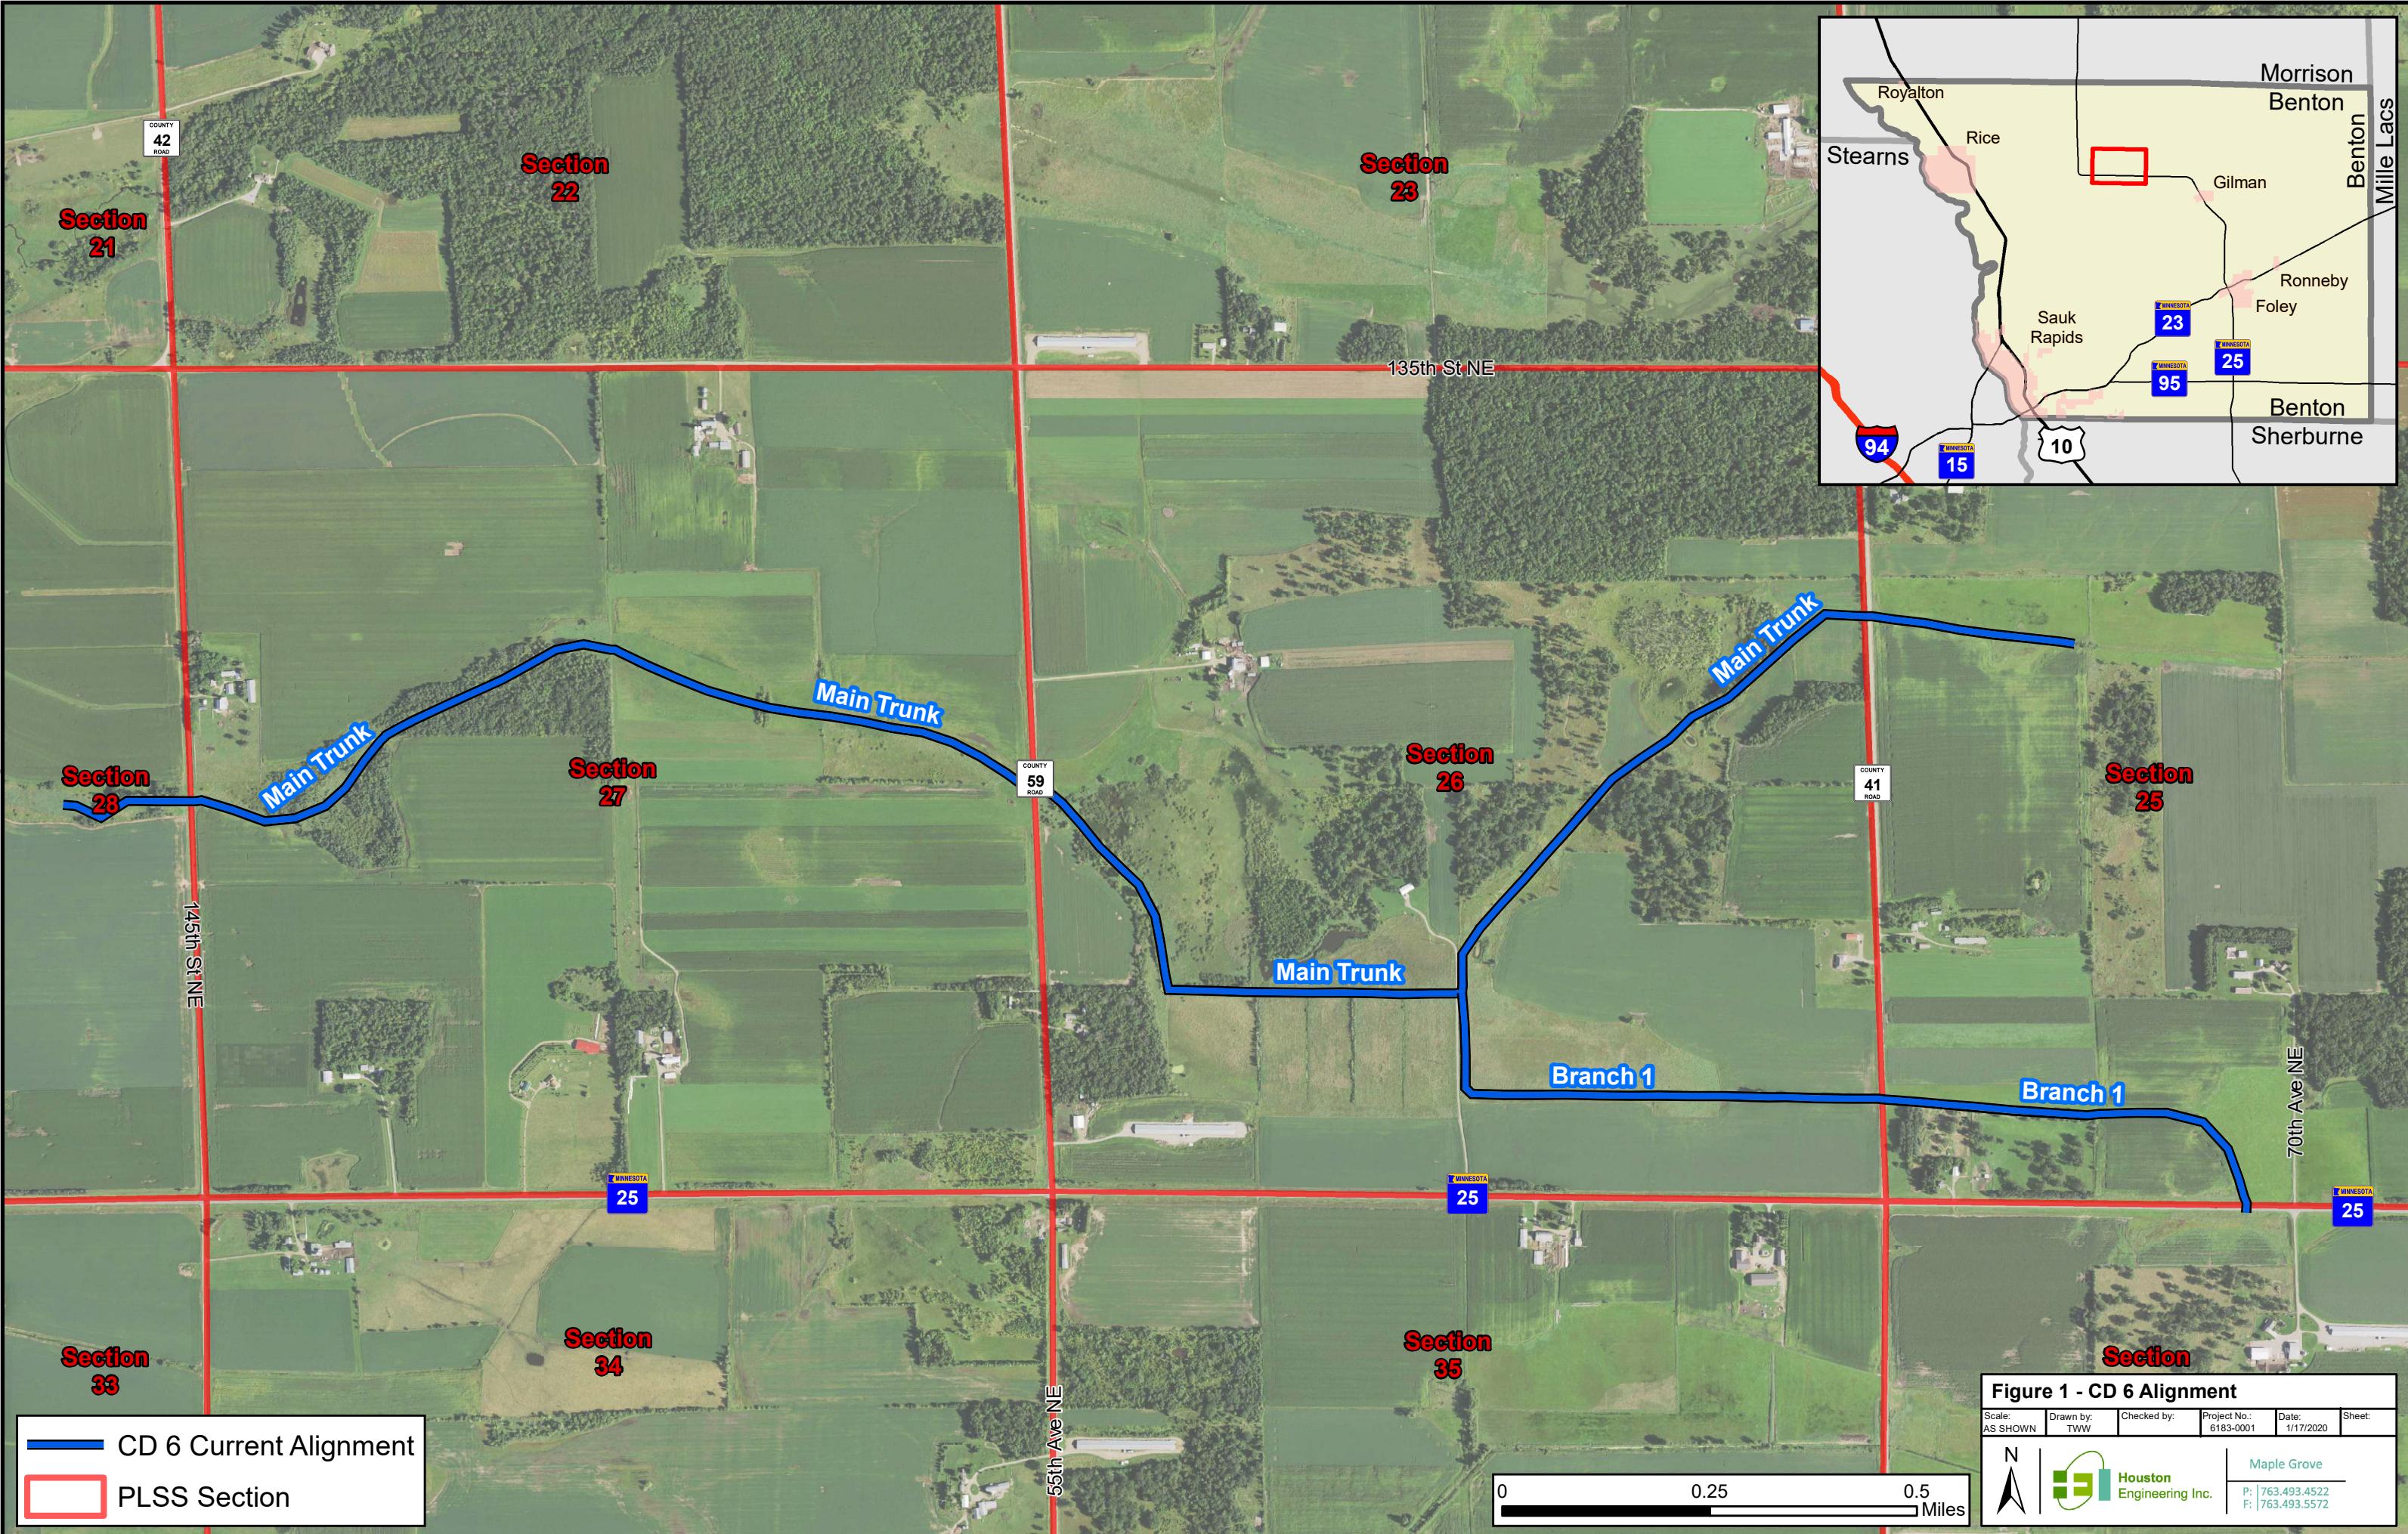
The Benton CD 6 public drainage system, shown in **Figure 1**, is located in Sections 25, 26, 27, and 28 (of T38N R30W) within Graham Township, Benton County. CD 6 consists of a Main Trunk and one branch. The Main Trunk generally flows from east to west, beginning at the NE quarter of the SE quarter of Section 28 and ending in the SW quarter of the NW quarter of Section 25. Branch 1 generally flows east to west, beginning where it intersects the Main Trunk at the SW quarter of the SE quarter of Section 26 and ending at State Highway 25 in the SE quarter of the SW quarter of Section 25. The drainage area that contributes to the CD 6 public drainage system is approximately 1,805 acres (**Figure 2**) and is in Sections 19 and 30 of (T38, R29W) and Sections 22, 23, 24, 25, 26, 27, 28, 35, and 36 (T38, R30W). The predominant land use in the drainage area is agricultural along with wetland, forest, and rural residential.

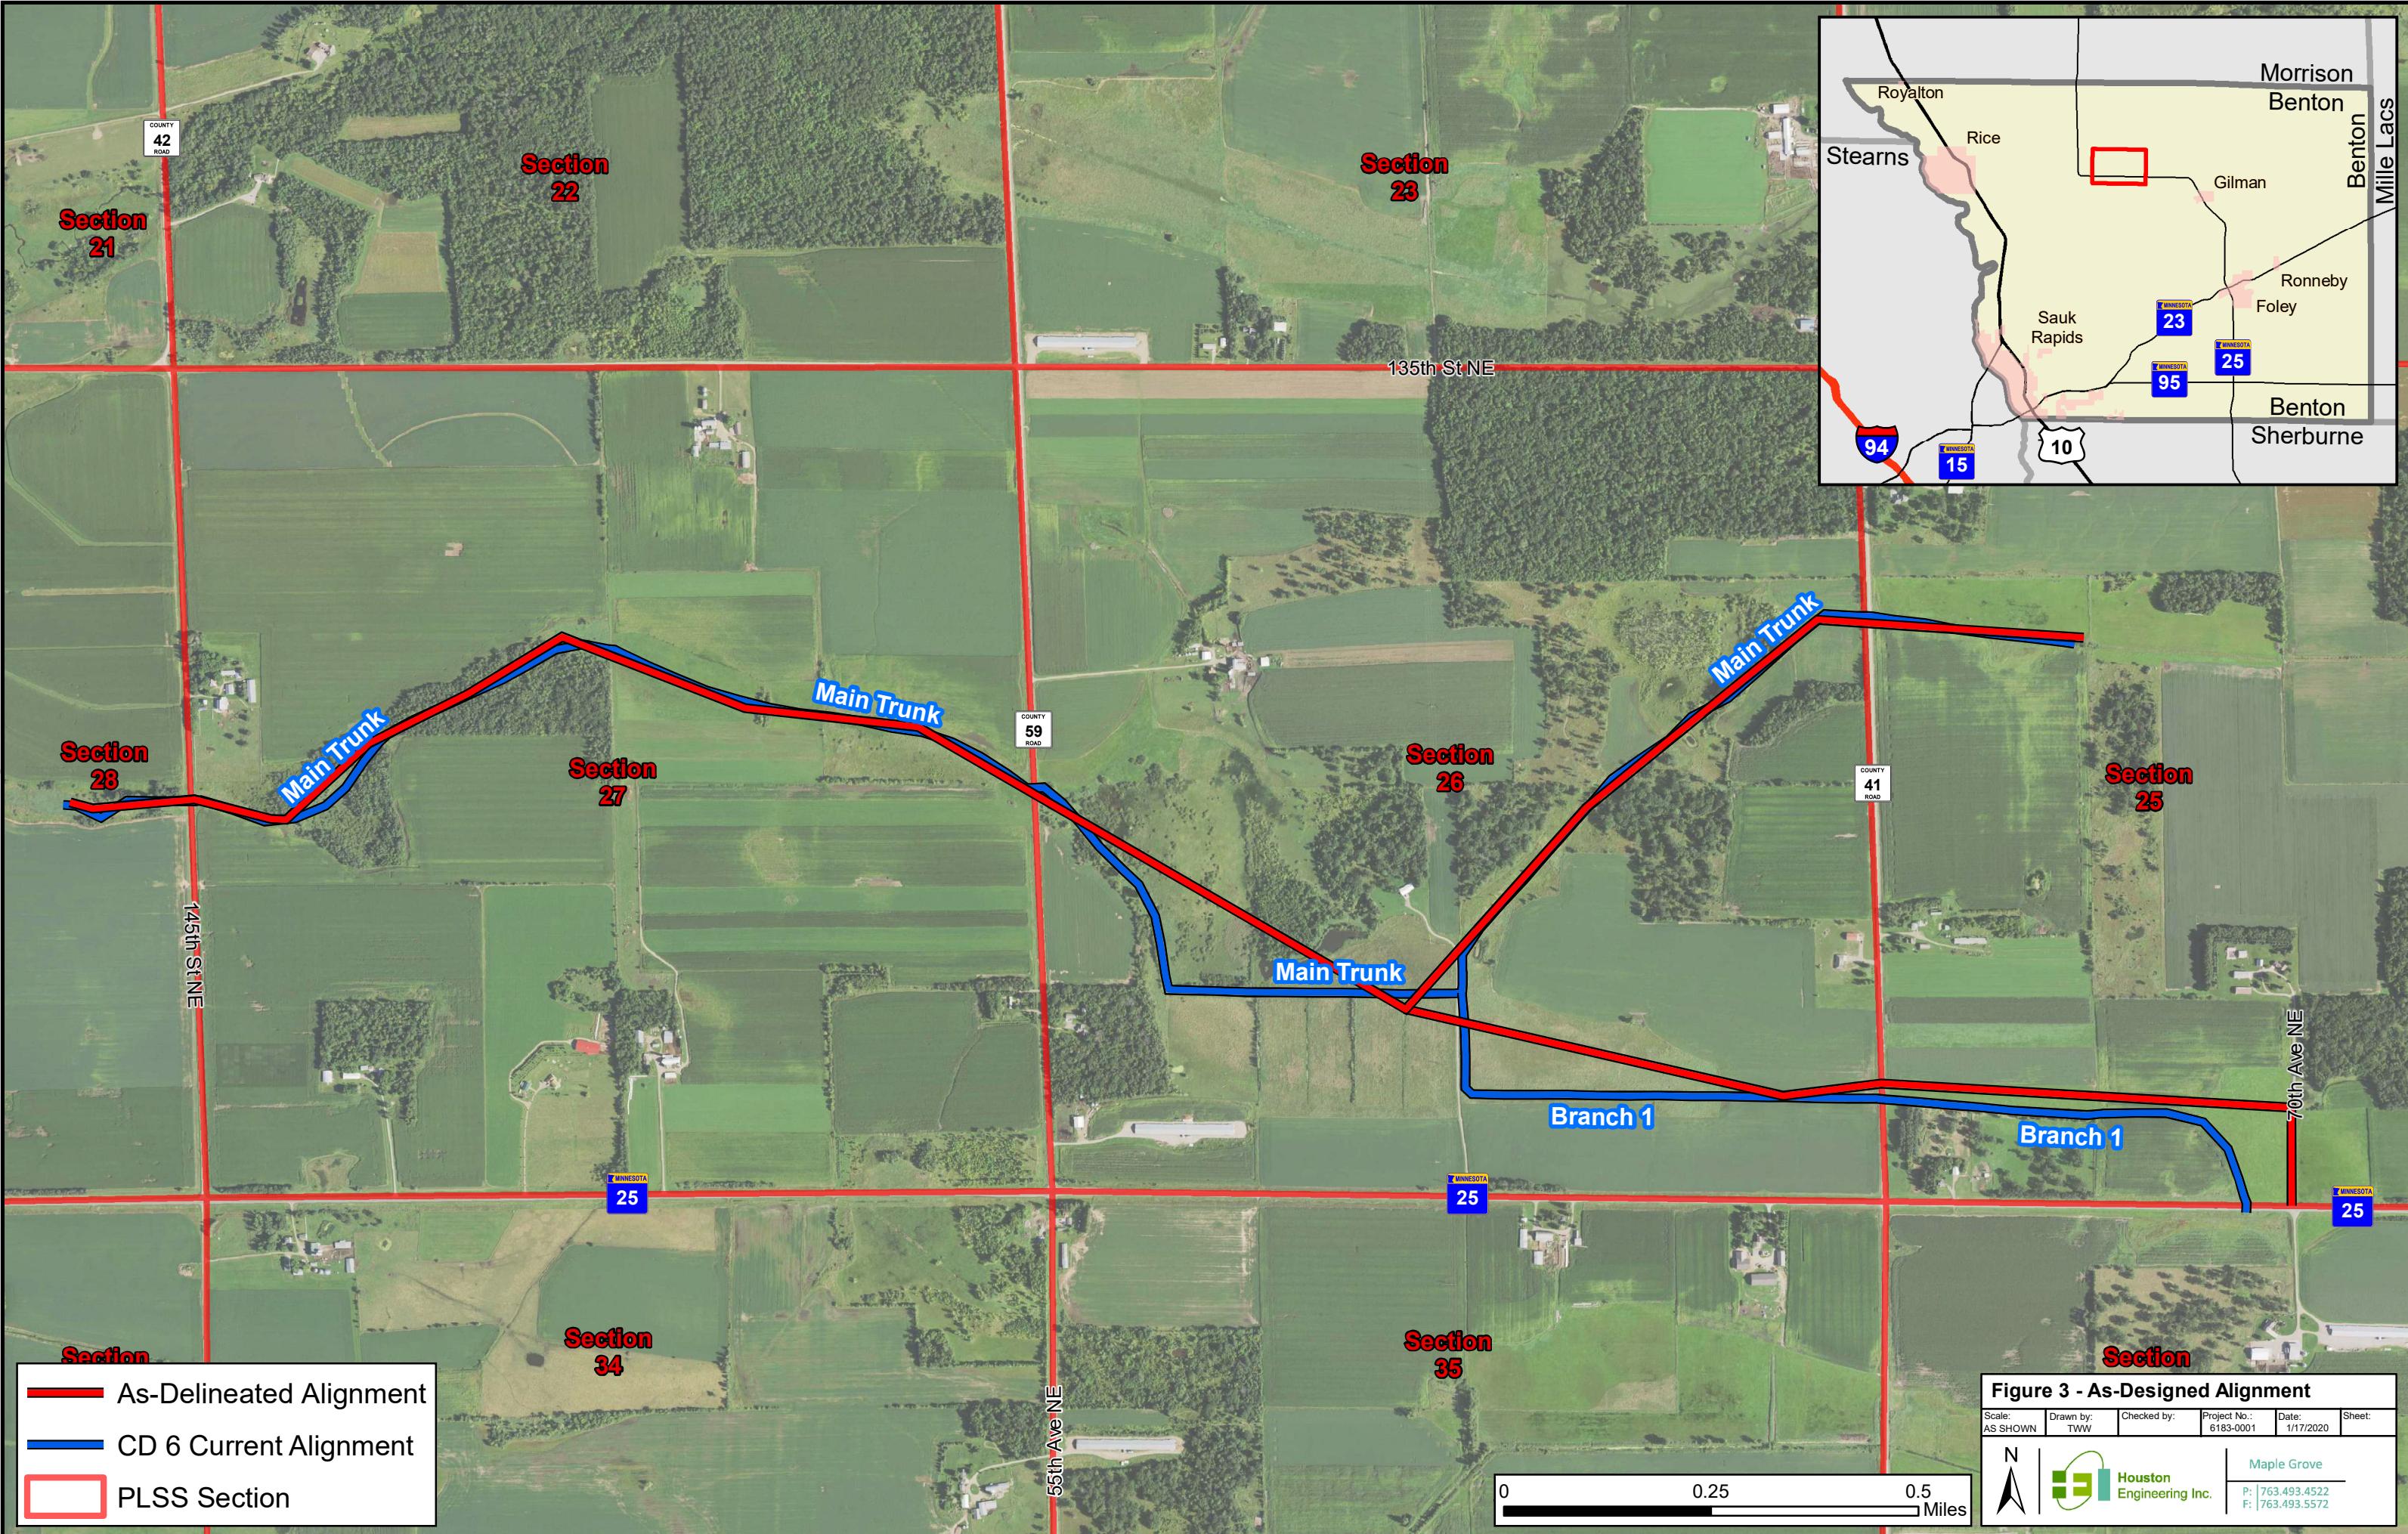
The CD 6 original 1905 design profiles were based on an assumed vertical datum referring to a benchmark no longer in existence, and as-built plans are not available. To determine the ACSIC in a modern vertical datum, soil borings collected during field survey were used to determine "as-built" excavation depths where the material transitions from accumulated sediment to native mineral soil. Soil borings were excavated along the system as shown in **Attachment A**. In total, 29 soil borings were collected during the field survey (23 along the Main Trunk and 6 along Branch 1).

A statistical comparison of the soil borings and original design profile elevations was then performed. Through the comparison process, a datum adjustment factor was calculated to convert the design profile from the local datum to NAVD88. Soil borings elevations that were not within one standard deviation from the datum adjustment calculated from the entire set of soil boring elevations were deemed to be outliers and were removed from the final datum adjustment calculation. The reaches where the channel was “realigned” were excluded from statistical comparison because the alignment varies from the design alignment and thereby, the design profile.

When the statistical analysis was completed and the outliers removed, the remaining data was not a proportionately large enough sample size to be statistically significant. Therefore, the ACSIC profile was instead determined by drawing a best fit line using the soil borings. The resulting profile, shown in **Attachment A**, provides very good correlation to the soil borings (with only one outlier) while still matching the geographic location of grade breaks denoted in the historic profile.

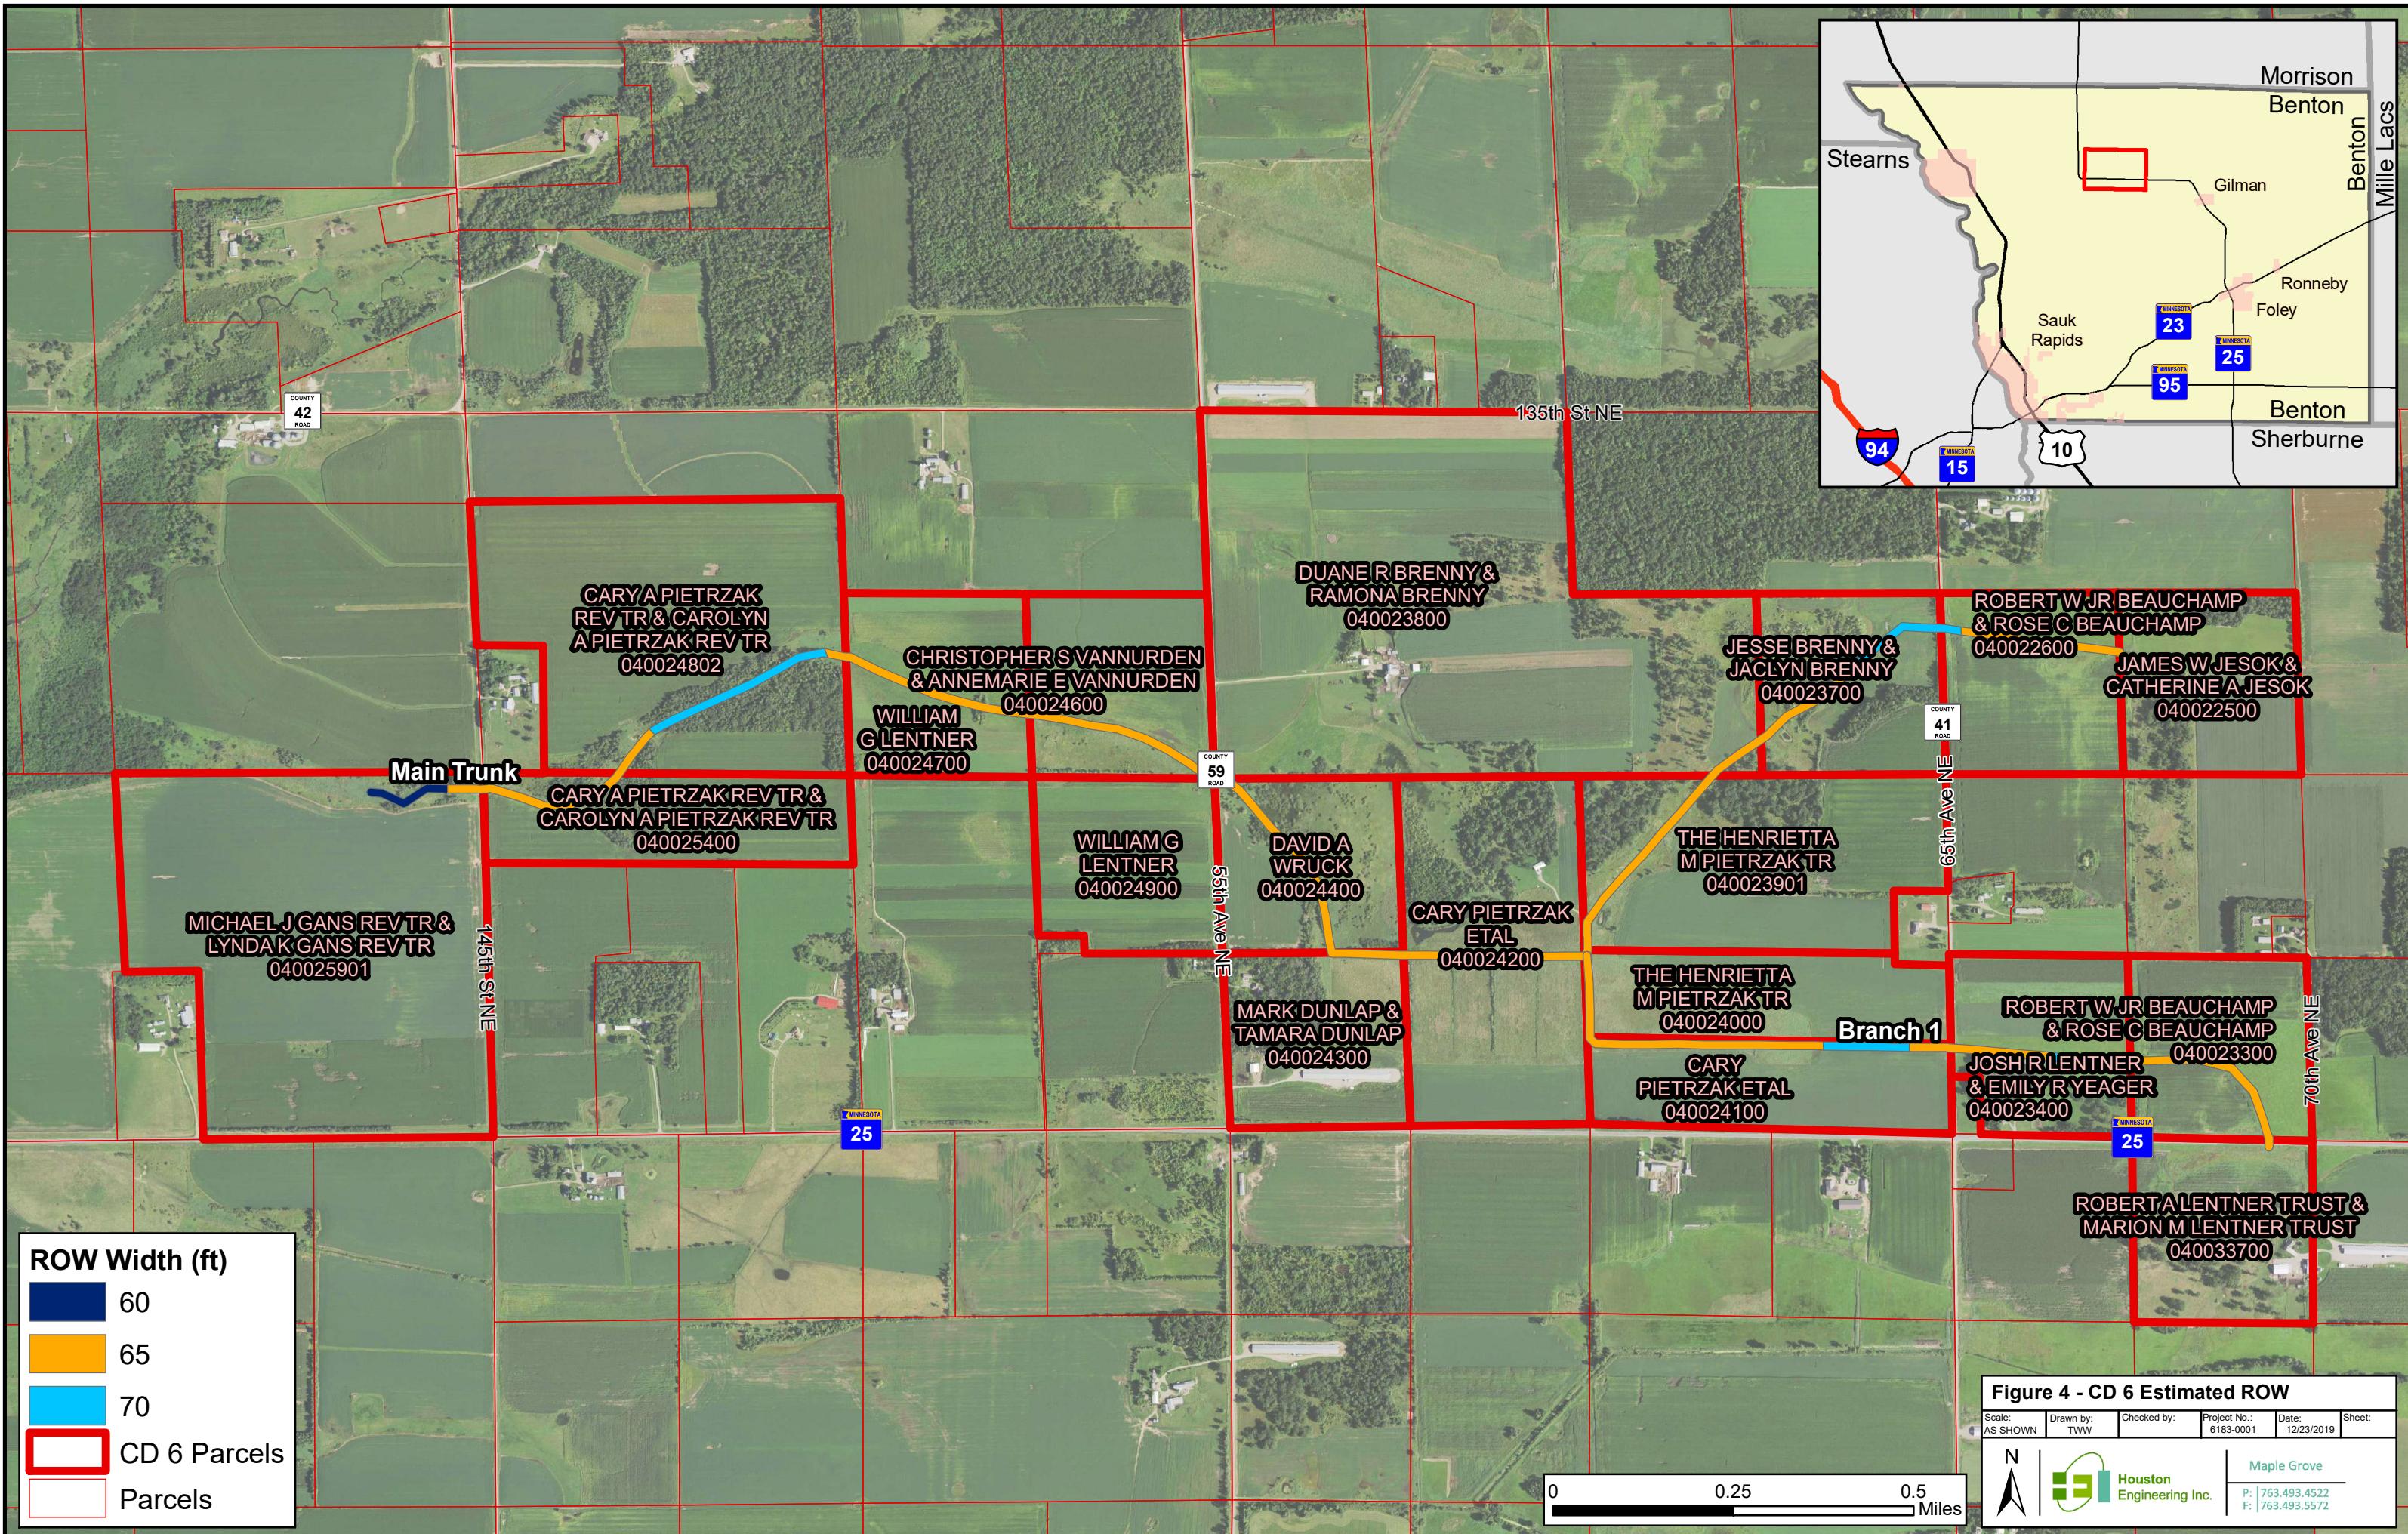
The minimum length of spoil on each side of the ditch was set to 25 feet and total ROW width was calculated by adding together the top width of the as-designed ditch and the assumed length of spoil on either side of the ditch. The total ROW width varied along the ditch system, but sections of the ditch were grouped based on similar widths. Total ROW widths for CD 6, centered on the channel, can be found in **Table 4** and are mapped in **Figure 4**.

Proceedings for the original establishment of the drainage system awarded damages for the areas physically occupied by the drainage system along with an easement for the area required for construction activities such as land clearing and spoil disposal. This combination of areas constitutes the right-of-way (ROW) for the drainage system and is often described as the area reasonably necessary for the drainage authority to perform its repair, maintenance, inspection obligations, along with an area of reasonable set-back to protect the drainage system. **Figure 4** shows the area estimated to have been utilized during construction.

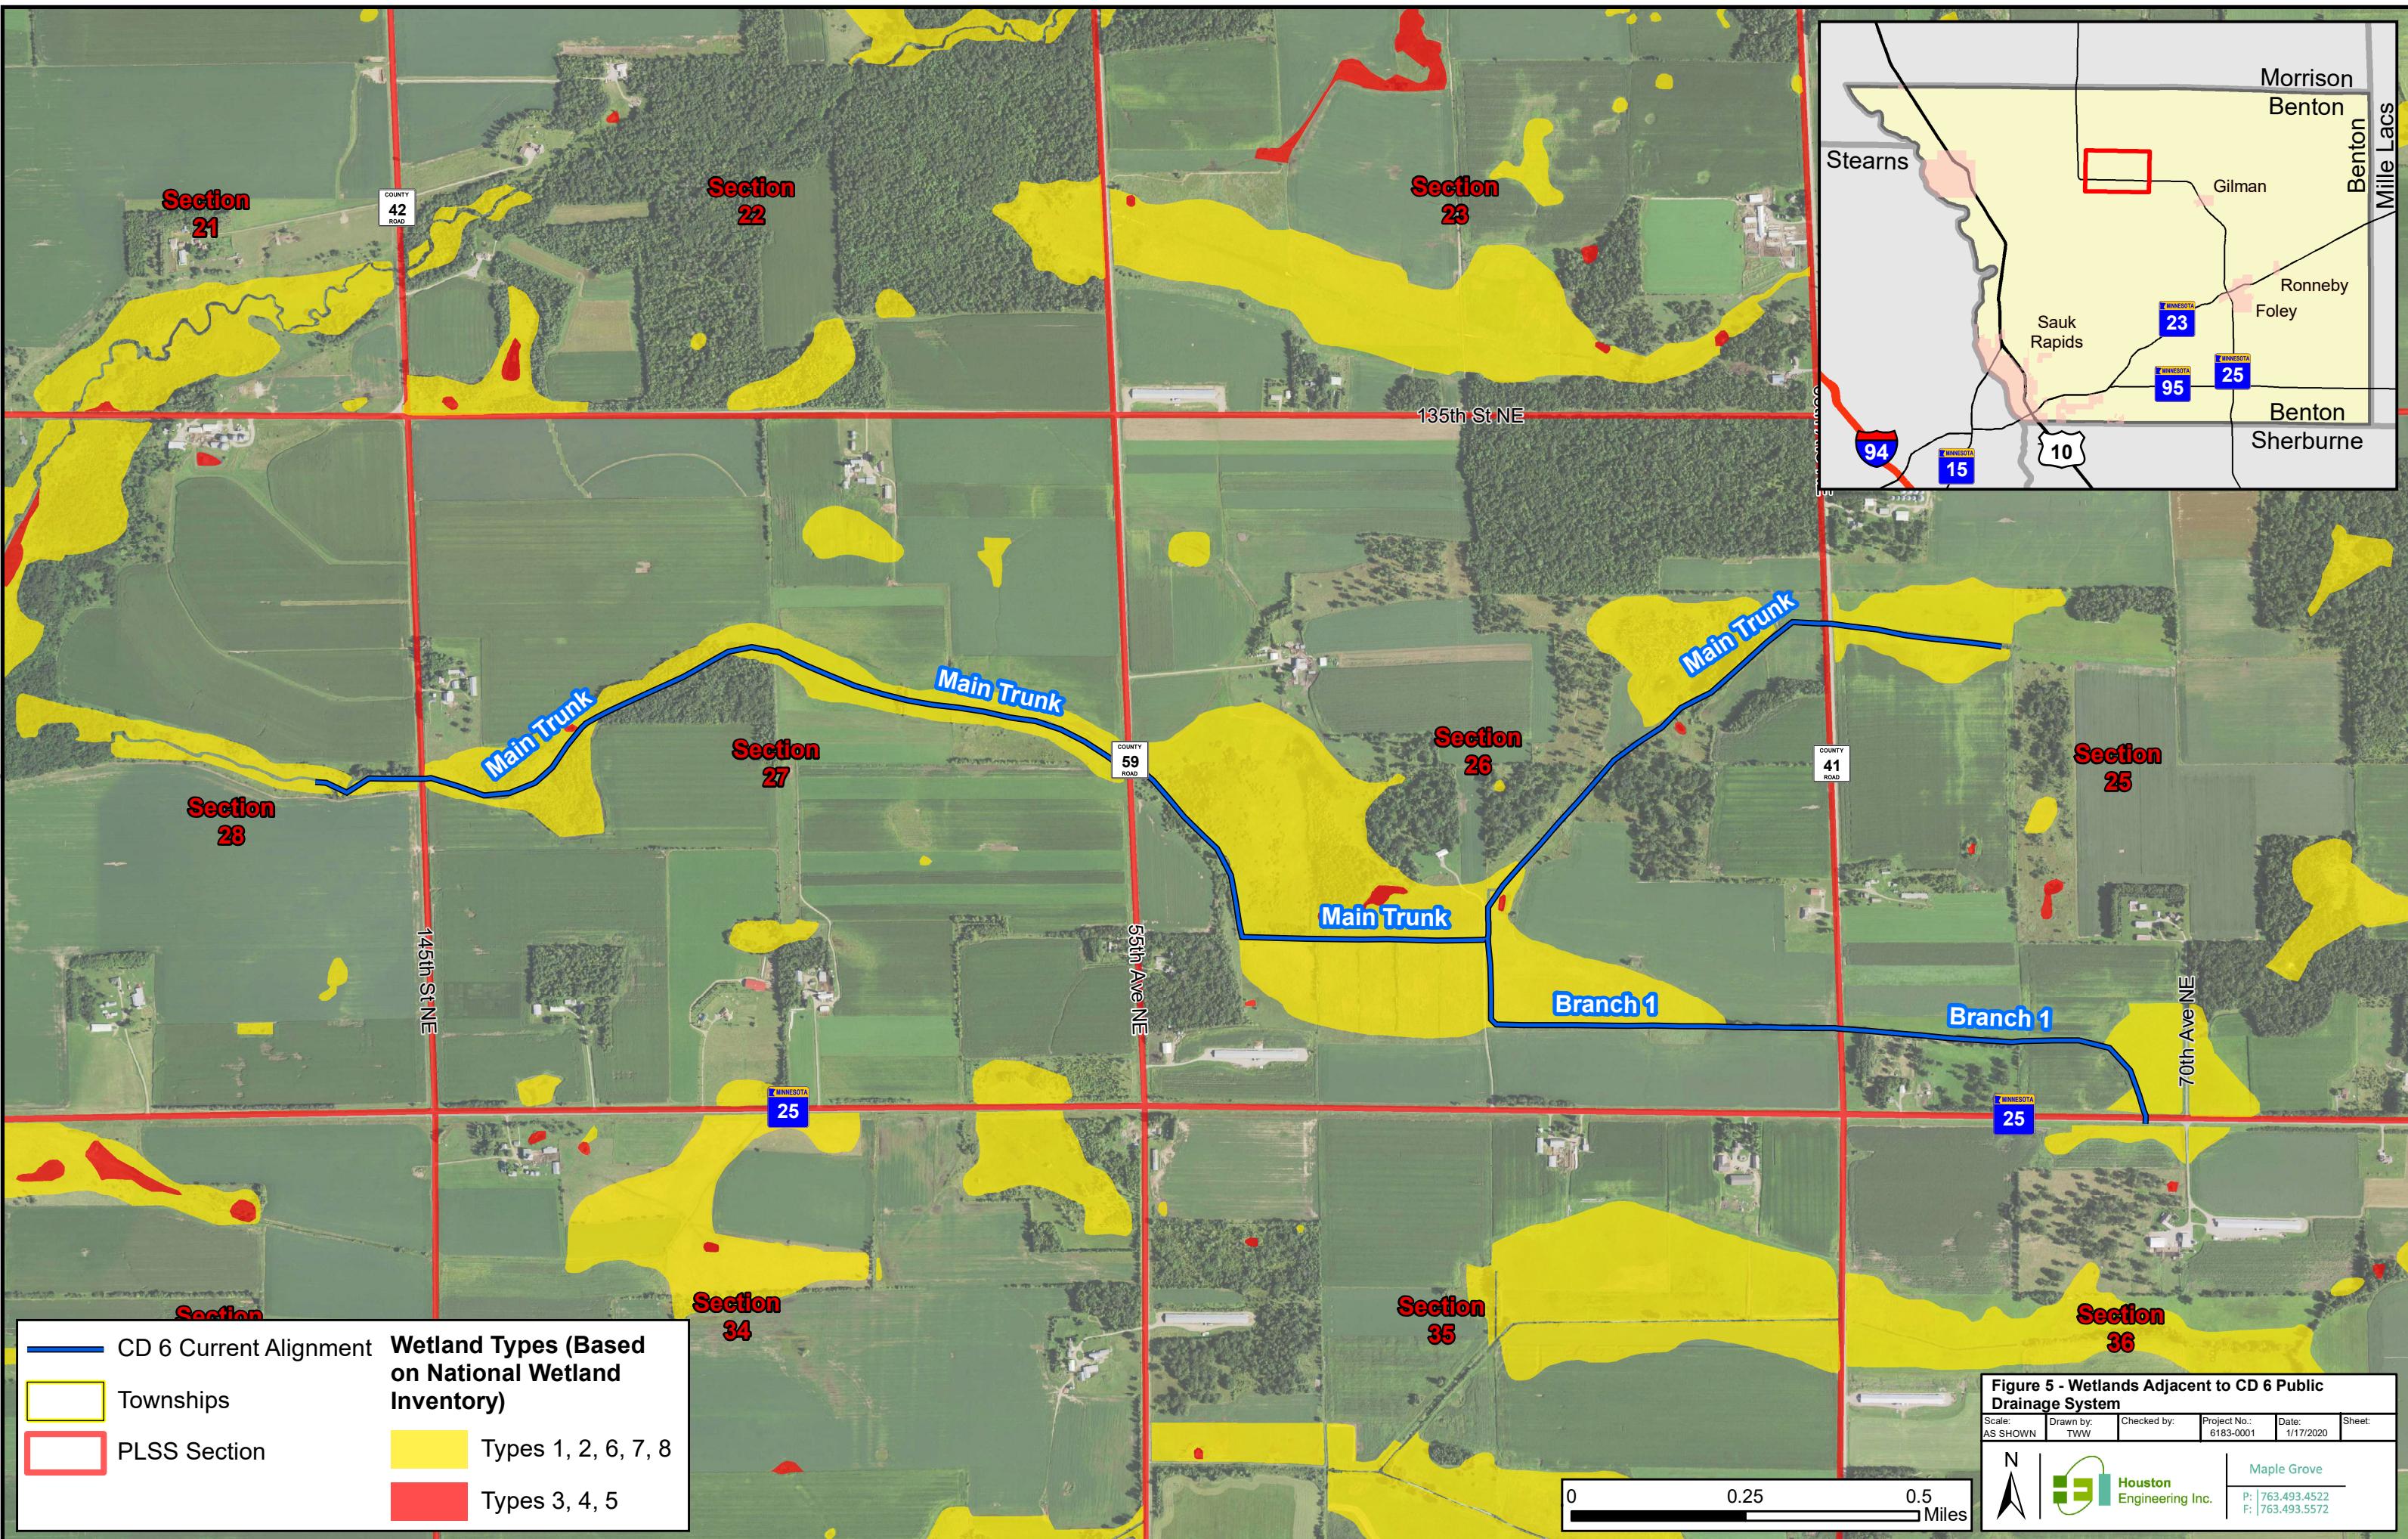
The CD 6 public drainage system intersects wetlands identified in the U.S. Fish and Wildlife Service National Wetland Inventory (NWI) as shown in **Figure 5**. There are no listed public waters along the CD 6 public drainage system. Under most regulatory programs (i.e. Minnesota Wetland Conservation Act (WCA), Federal Clean Water Act (CWA); and Minnesota Public Waters Law), activities related to repair of a public drainage system, though potentially taking place within the confines of wetlands, are not considered to result in jurisdictional wetland loss. These activities related to public drainage system maintenance include:

There appear to only be four Type 3, 4, or 5 wetlands near the public drainage system, none of which have an obvious open water connection to the ditch. Potential impacts should be assessed during a repair report.

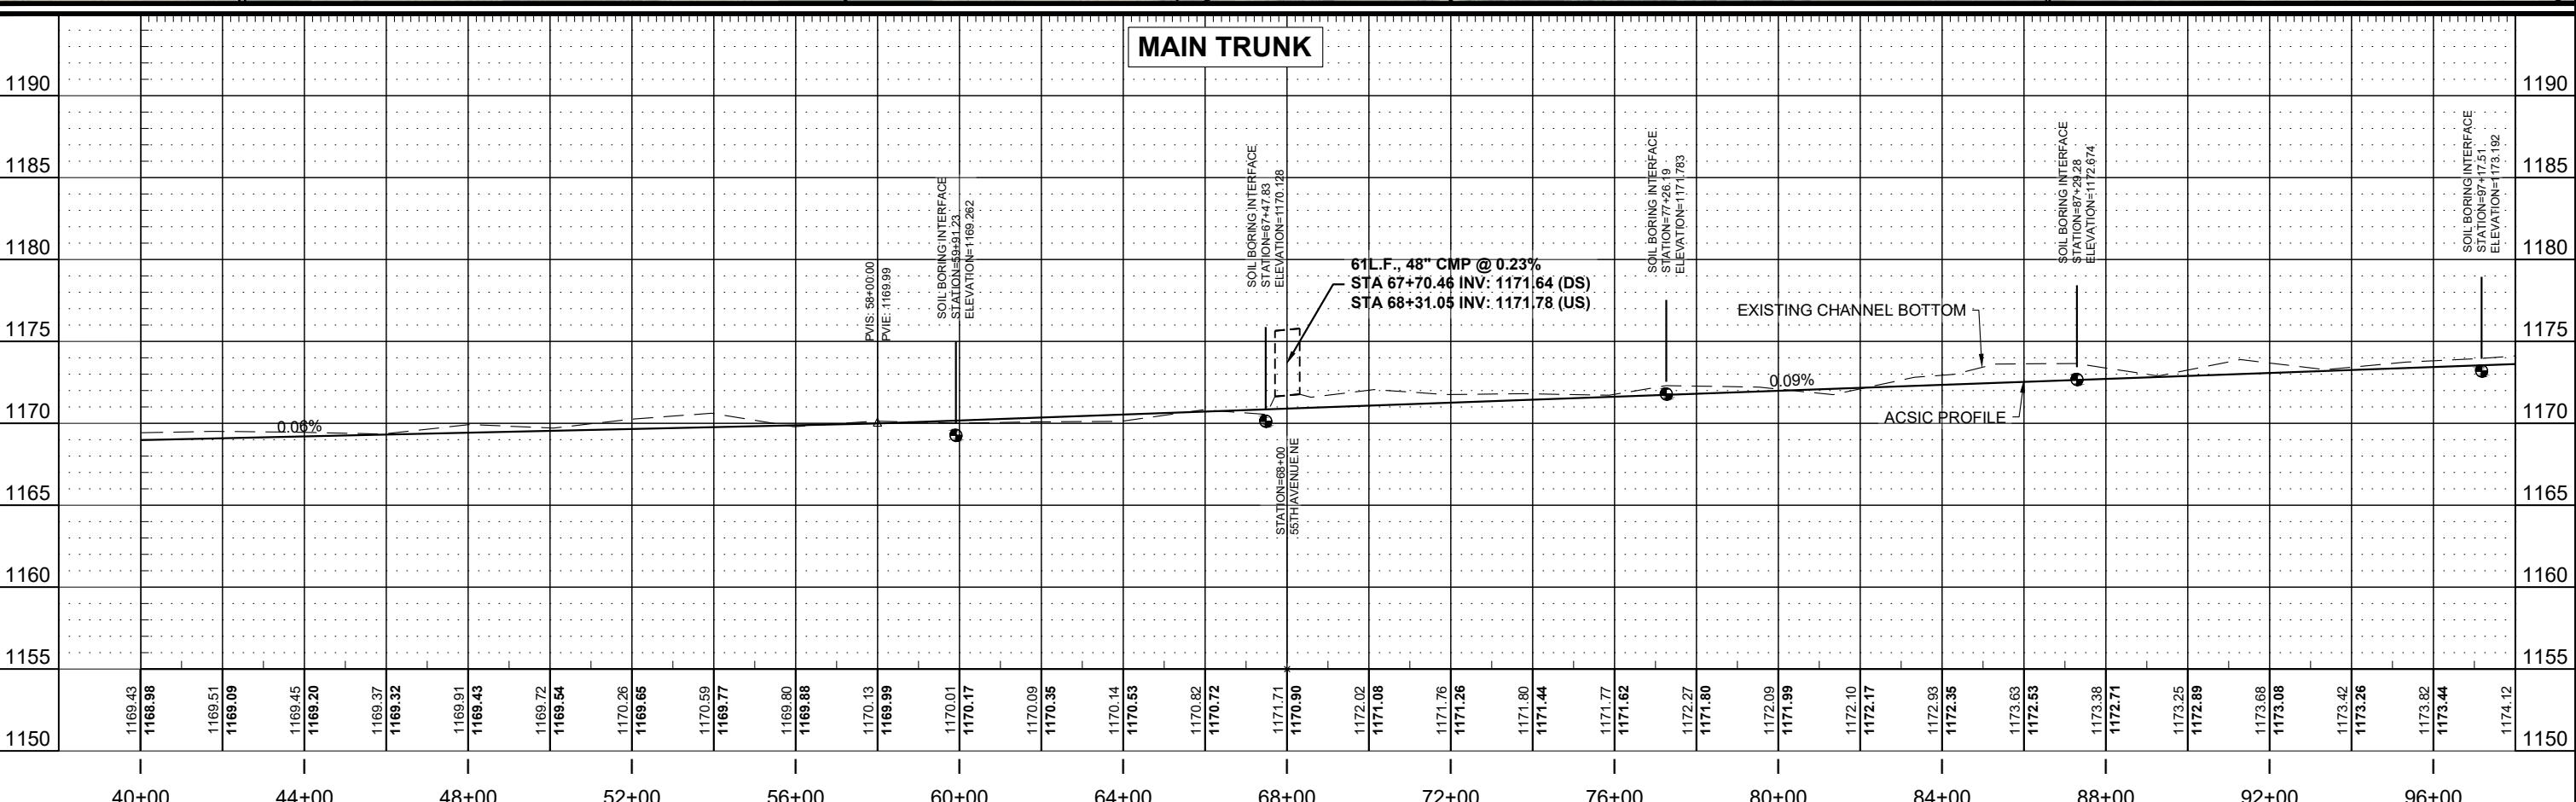
**NOTE:**  
AS-CONSTRUCTED AND SUBSEQUENTLY IMPROVED CONDITION (ACSC) BASED ON A BEST FIT OF THE SOIL BORINGS.

30L.F., 42" CM  
STA 102+53.4  
STA 102+83.8
