Benton County Ditch 14 Record Re-establishment Public Hearing

Garrett Monson, PE
Benton County | August 18, 2020

Record Reestablishment Purpose

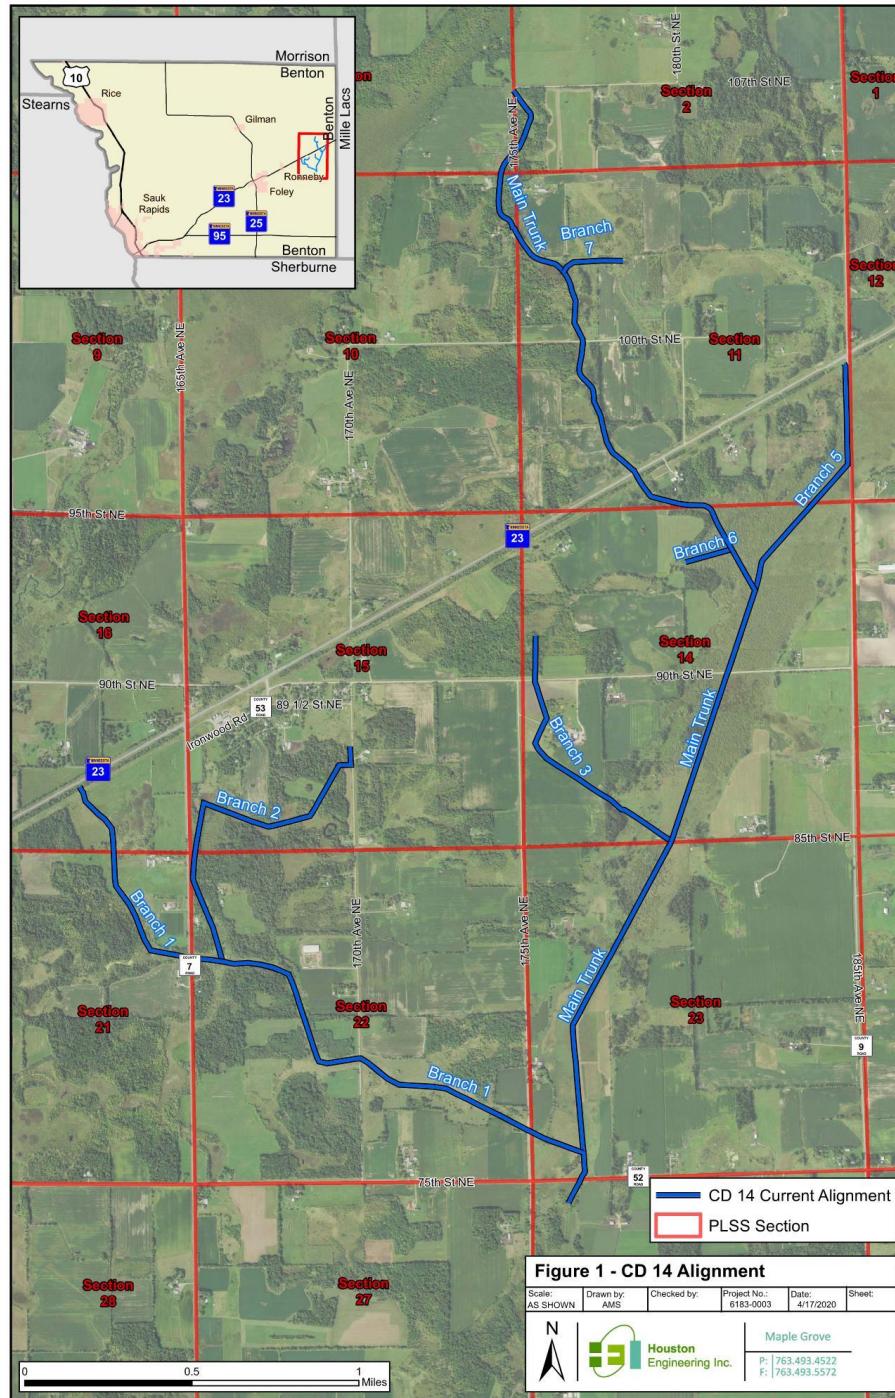
CD 14 Location and History

- Maywood Township
- Approx. 9 miles of open channel ditch
- Established in 1915
- Main Trunk and 6 Branches
- Small repair of downstream end into CD 9 in 2004

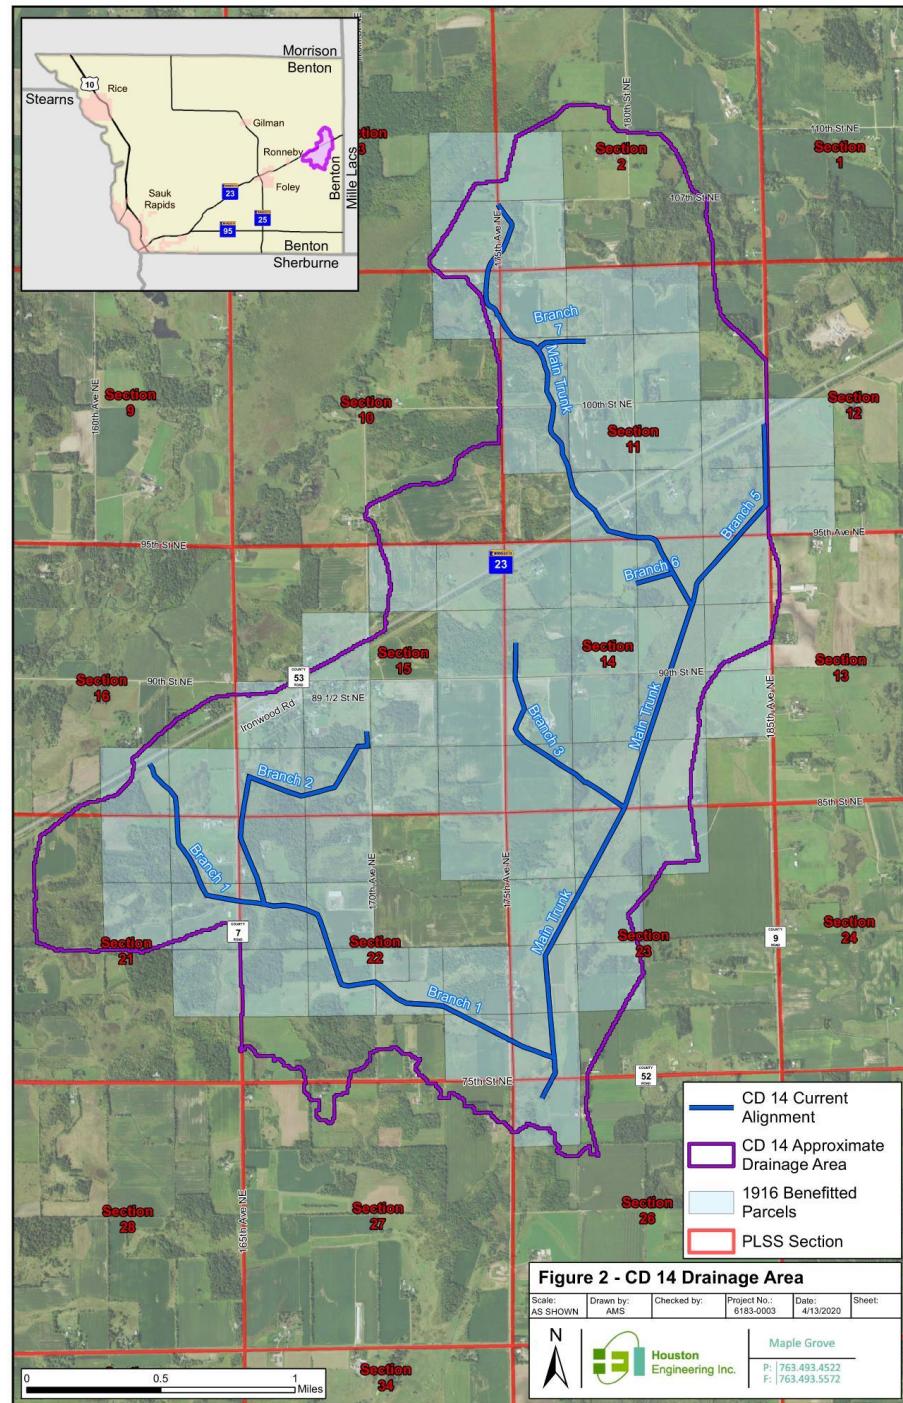
Benefitted Area

- Drains ~3,340 acres
- 1916 Viewers Report identifies 1,373 benefitting acres

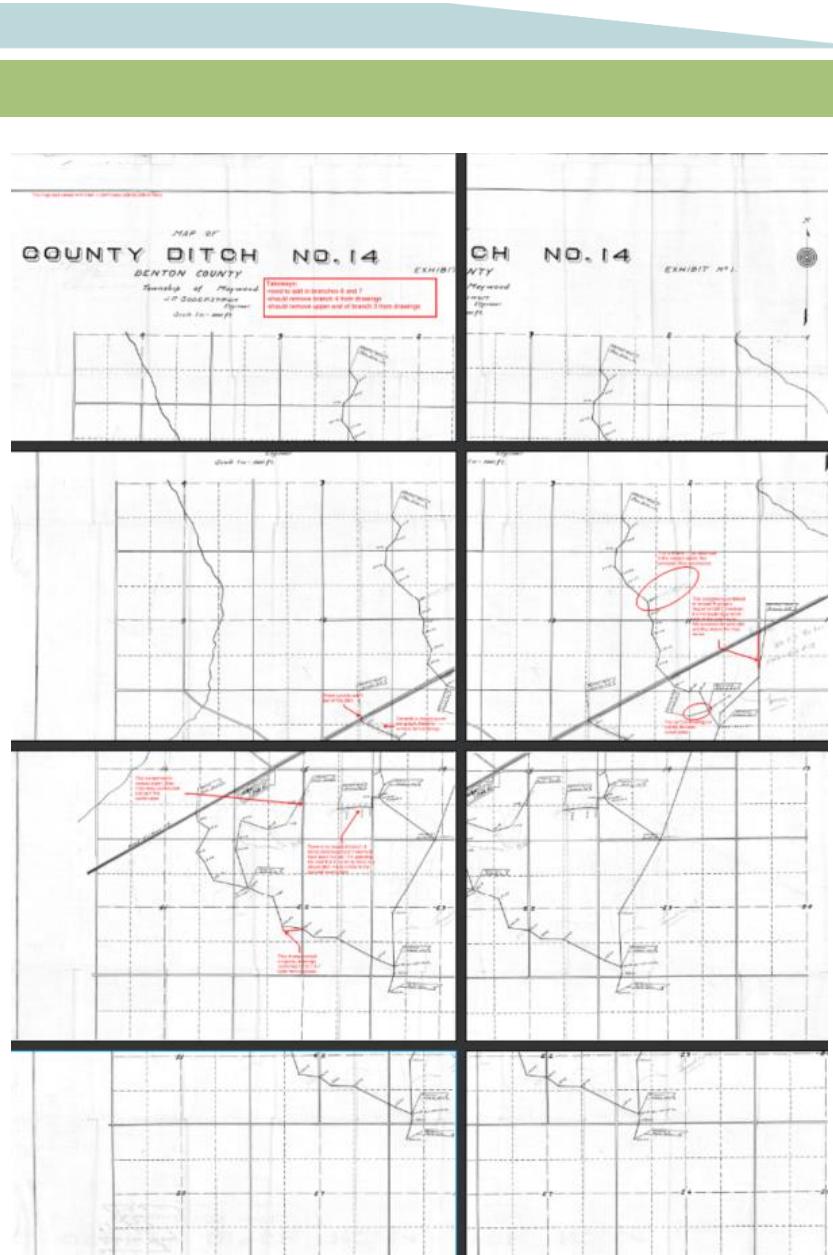
Determination of the As-Constructed Alignment

- Review established alignment
- Review construction documents
 - a small adjustment was made on Branch 1
 - Branch 4 was never constructed
- Current alignment reflects ACSIC

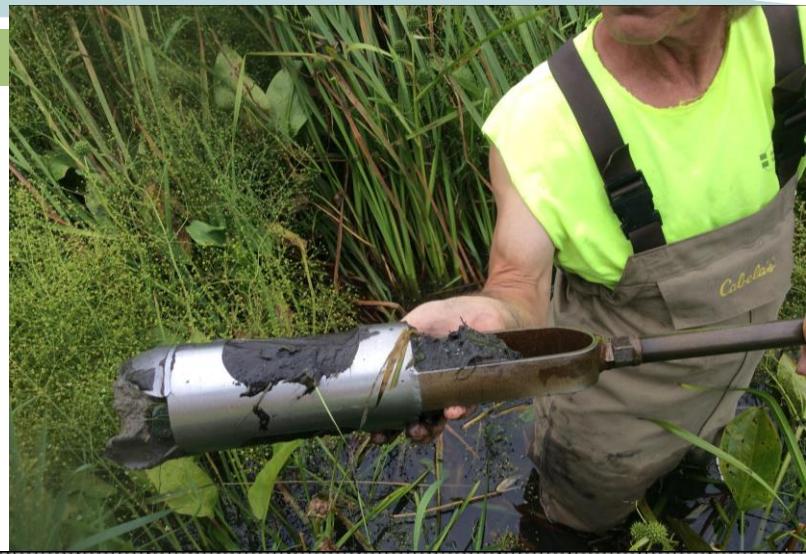
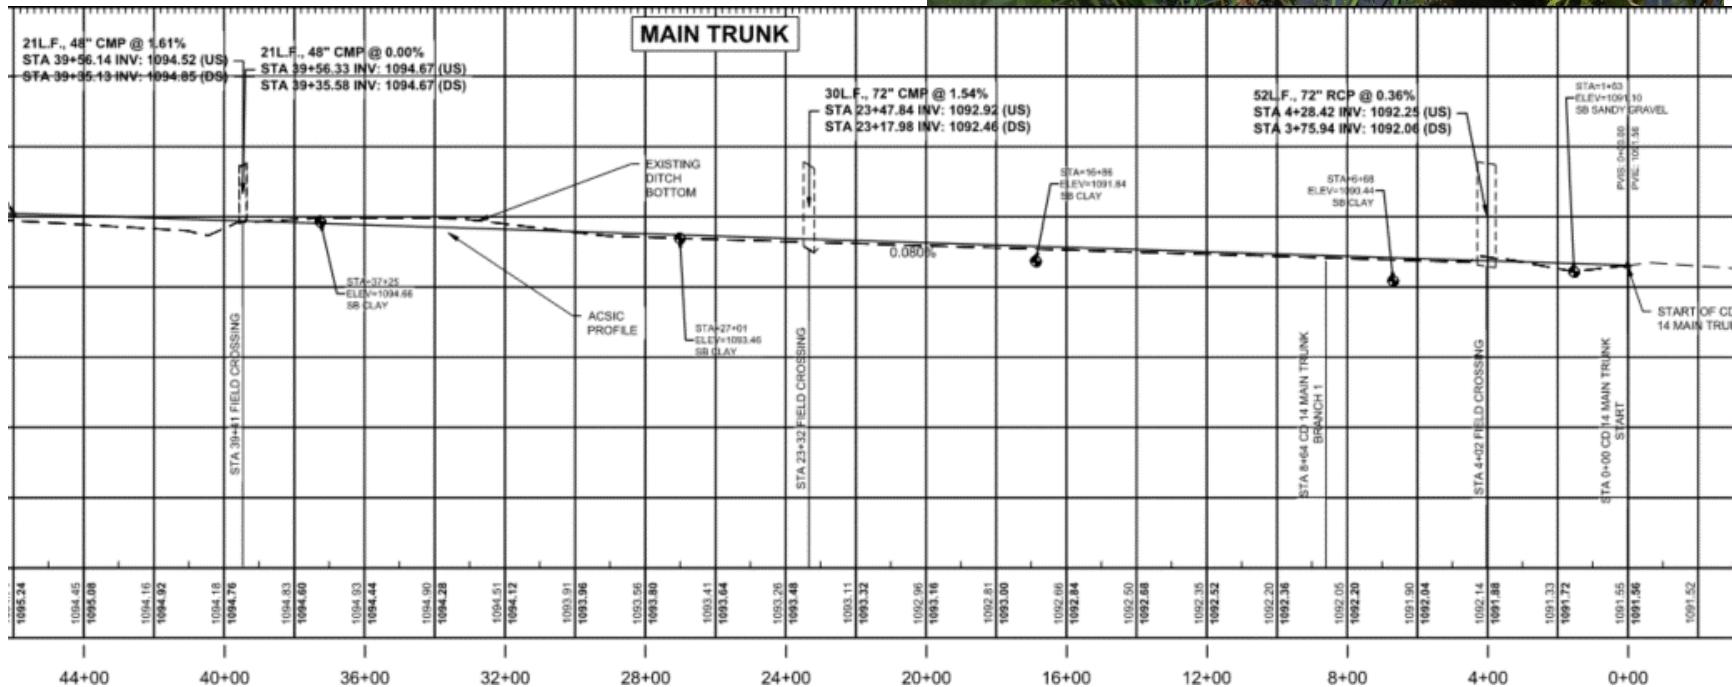
Determination of the As-Constructed Grade

- Soil probes identify the hard bottom of open channel ditch

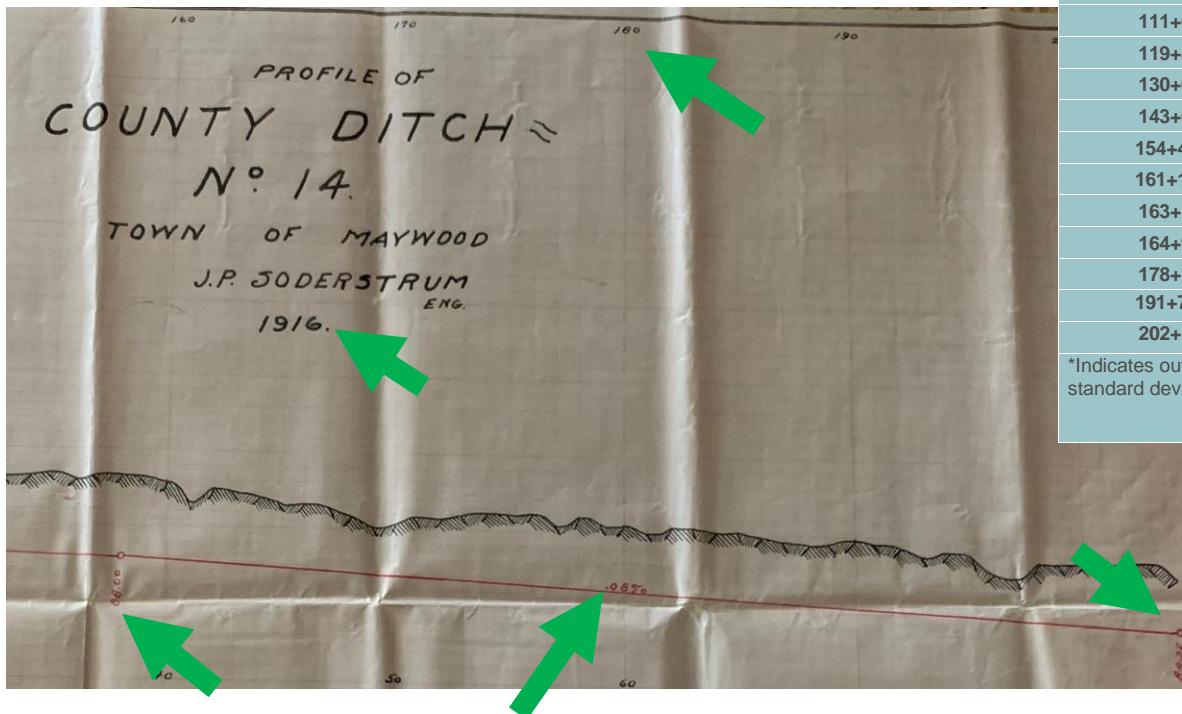
Determination of the As-Constructed Grade

- Field surveyed bottom of channel are compared to the design profile

Current CD 14 Alignment Station	Soil Boring Elev.	1916 Profile Elev.	Deviation from Datum Adjustment of 1007.24
1+53	1091.1	84.42	-0.56
6+68*	1090.44	84.84	-1.64*
16+86*	1091.84	85.65	-1.05*
27+01	1093.46	86.46	-0.24
37+25	1094.66	87.28	0.14
60+77	1095.72	88.58	-0.10
103+73	1097.85	90.32	0.29
105+28	1098.45	90.70	0.51
111+62	1098.93	92.26	-0.57
119+89	1100.02	93.47	-0.68
130+00	1105.81	98.76	-0.19
143+60	1115.16	107.94	-0.02
154+41*	1117.16	109.02	0.90*
161+13*	1118.79	109.69	1.86*
163+15	1117.64	109.89	0.51
164+91	1117.72	110.07	0.41
178+15	1118.93	111.39	0.30
191+74*	1124	115.15	1.61*
202+19	1123.62	116.20	0.18

*Indicates outlier that was not used in determining the Datum Adjustment (1 standard deviation value of 0.82)

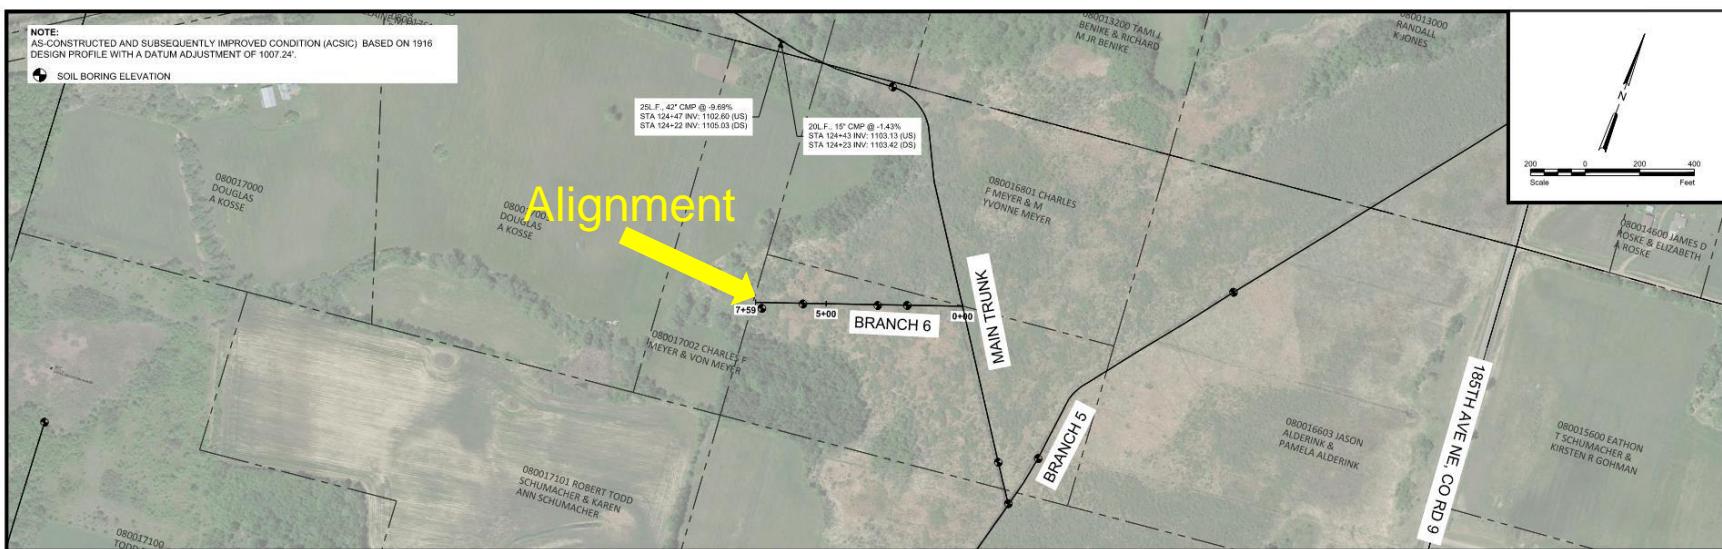
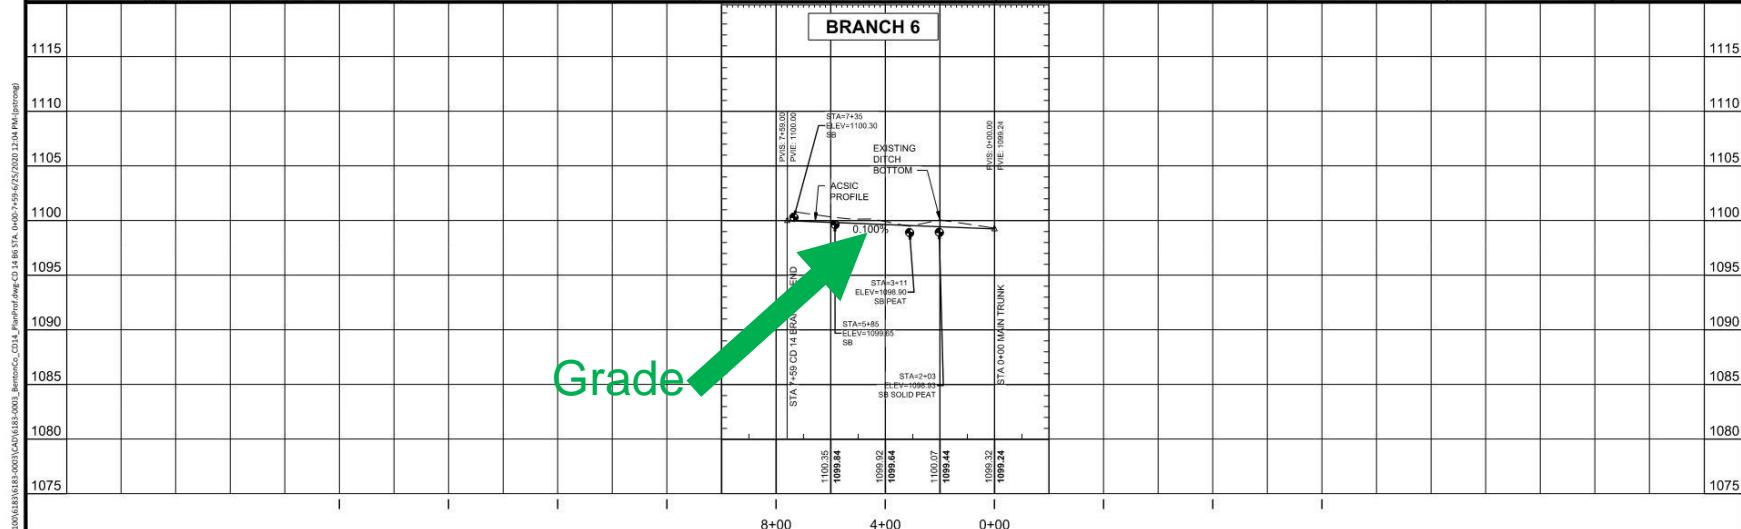
As-Constructed or Subsequently Improved Condition

No.	Revision	Date	By	PRELIMINARY Not for Construction	Maple Grove	Drawn by PAS	Date 5-15-20	REESTABLISHMENT OF BENTON COUNTY DITCH 14	BENTON COUNTY DITCH 14 BRA. 6 STA. 0+00 - 7+59 PROJECT NO. 6183-0003	SHEET 10 of 11
					P: 763.493.4522 F: 763.493.5572	Checked by GM	Scale AS SHOWN

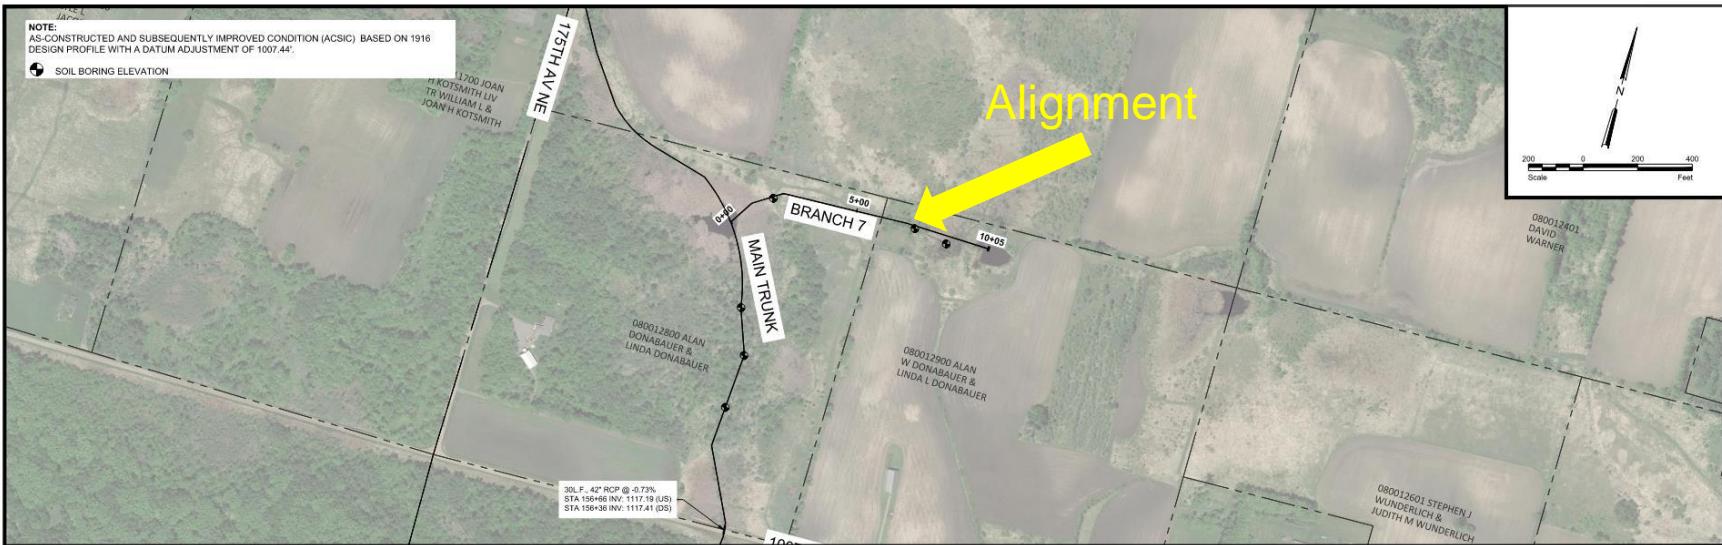
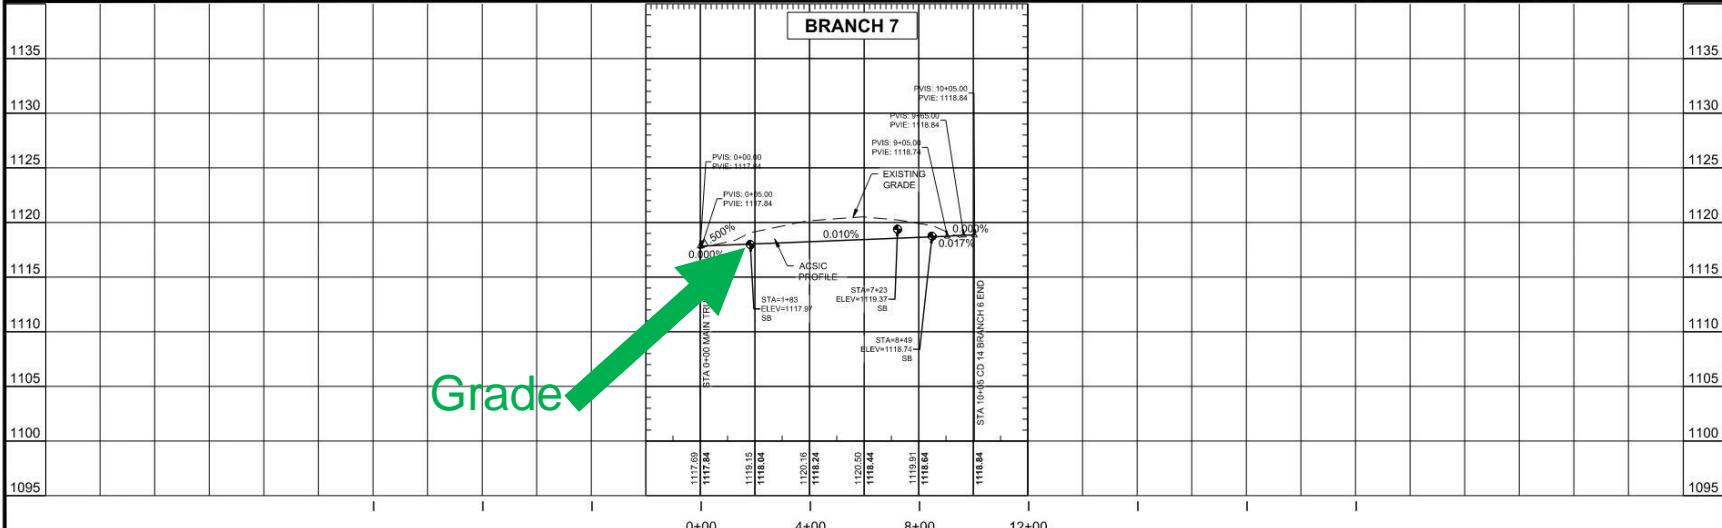
As-Constructed or Subsequently Improved Condition

BENTON COUNTY DITCH 14
BRA. 7 STA. 0+00 - 10+05
PROJECT NO. 6183-0003

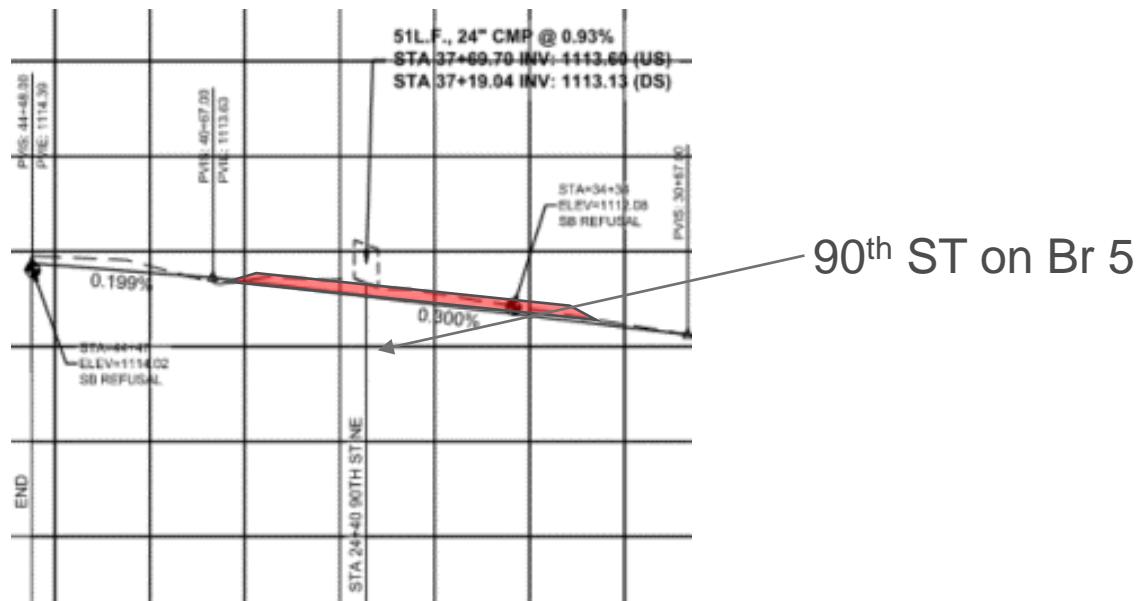
Why Are Some Culverts Higher Than ACSIC?

- Some roads weren't present or in present location in 1915
- Over years, sediment accumulated
- New or replacement culvert placed on top of existing sediment (not ACSIC)

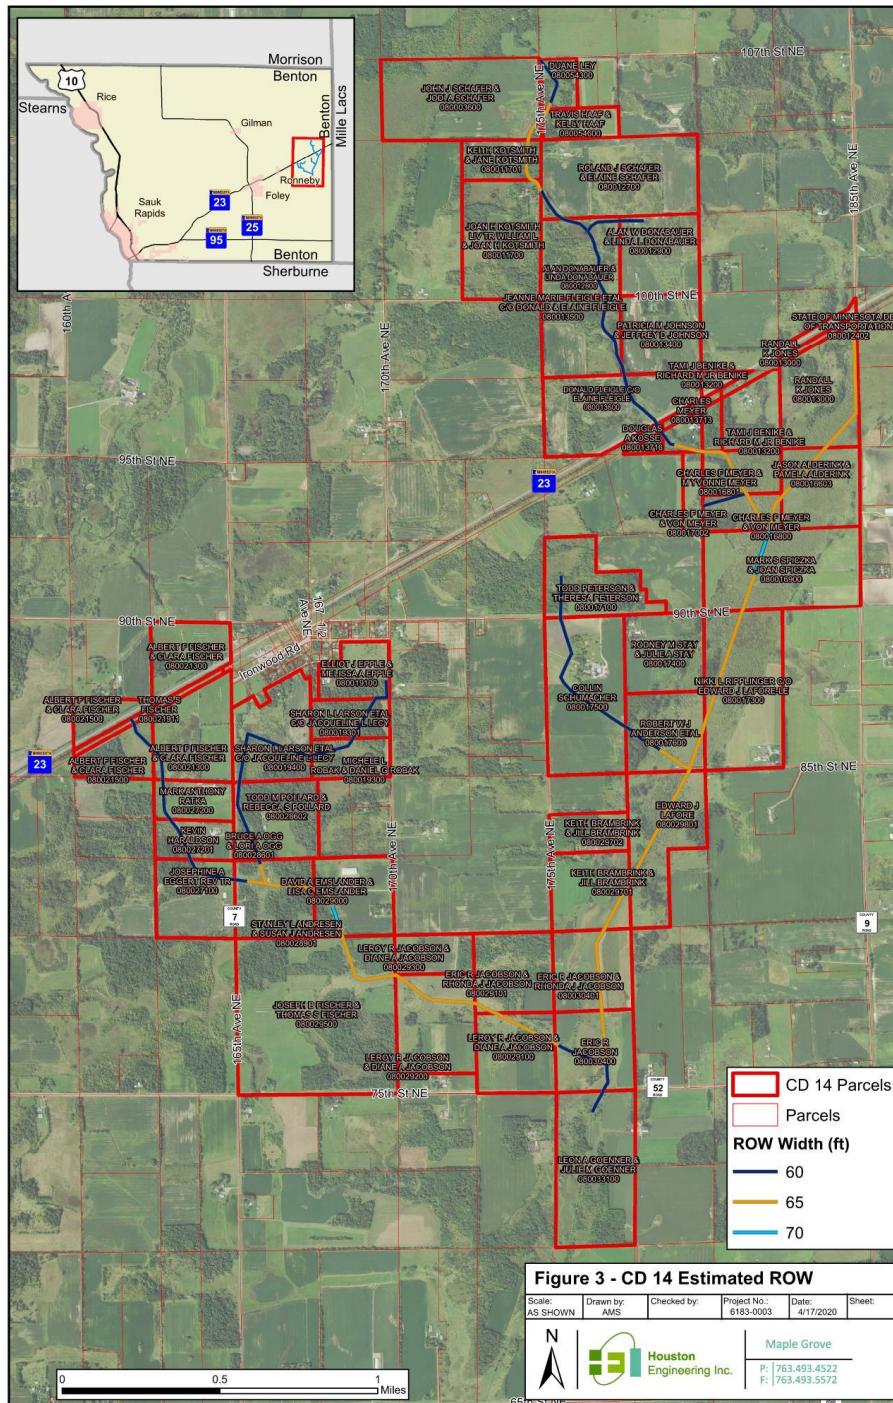
Right-of-Way

- Damages awarded during drainage system establishment for the:
 - Area physically occupied by the ditch
 - Area required to construct and maintain the drainage system
- Based on channel depths, visible spoil areas, topography

Downstream Station	Upstream Station	ROW Width (ft)
Main Trunk		0+00	96+00	65
		96+00	104+00	70
		104+00	127+00	65
		127+00	179+00	60
		179+00	196+00	65
		196+00	204+24	60
Branch 1		0+00	9+00	60
		9+00	55+00	65
		55+00	58+15	70
		58+15	74+00	65
		74+00	111+73	60
Branch 2		0+00	3+44	65
		3+44	57+78	60
Branch 3		0+00	6+00	65
		6+00	44+49	60
Branch 5		0+00	41+17	65
Branch 6		0+00	7+59	60
Branch 7		0+00	10+05	60

*Centered on the channel
