# Technical Memorandum

**To:** Chris Byrd, PE  
Benton County Engineer  
**From:** Garrett Monson, PE  
Houston Engineering, Inc.  
**Subject:** Benton County Ditch 6 Repair Report  
**Date:** April 21, 2021  
**Project:** 6183-0001

**BENTON COUNTY**  
**REPAIR REPORT**  
**FOR**  
**BENTON COUNTY DITCH NO. 6**  
**GRAHAM TOWNSHIP IN BENTON COUNTY**  
**JANUARY 2021**

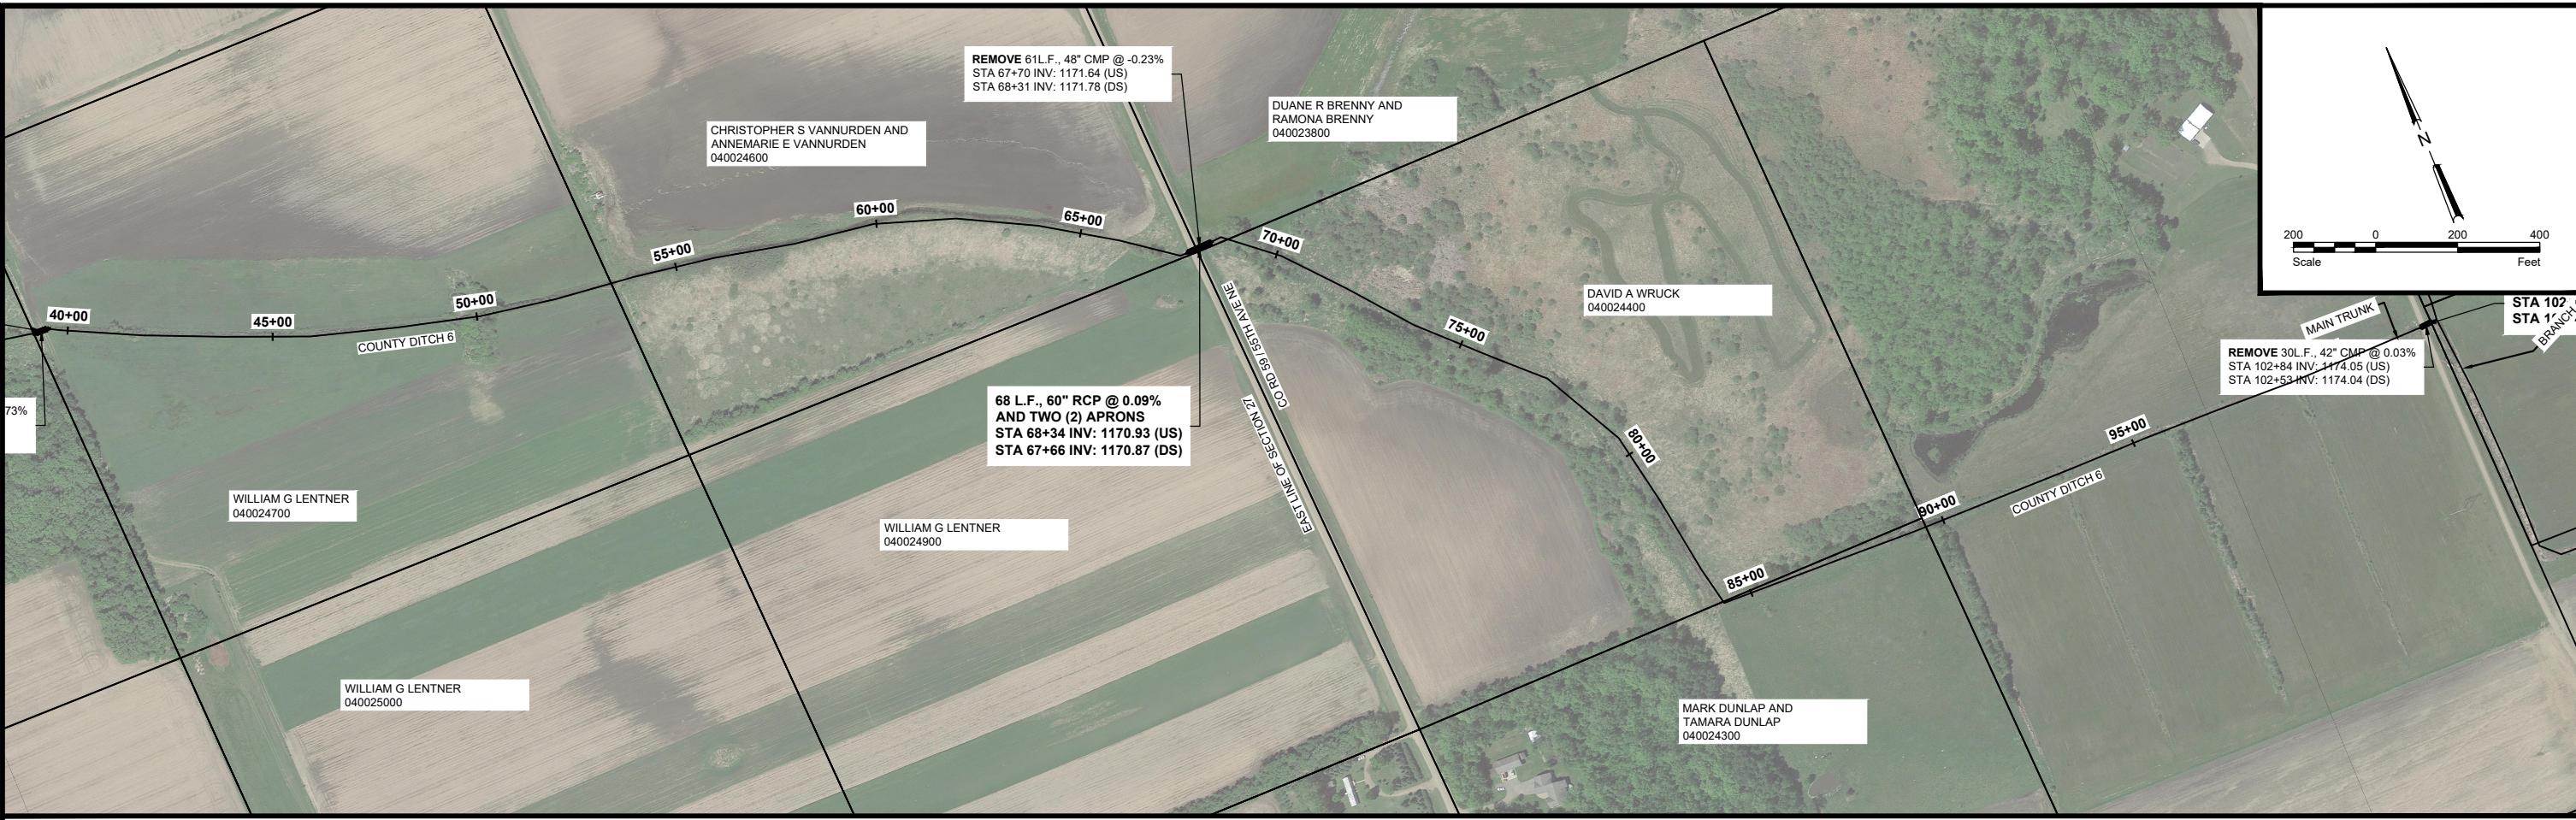
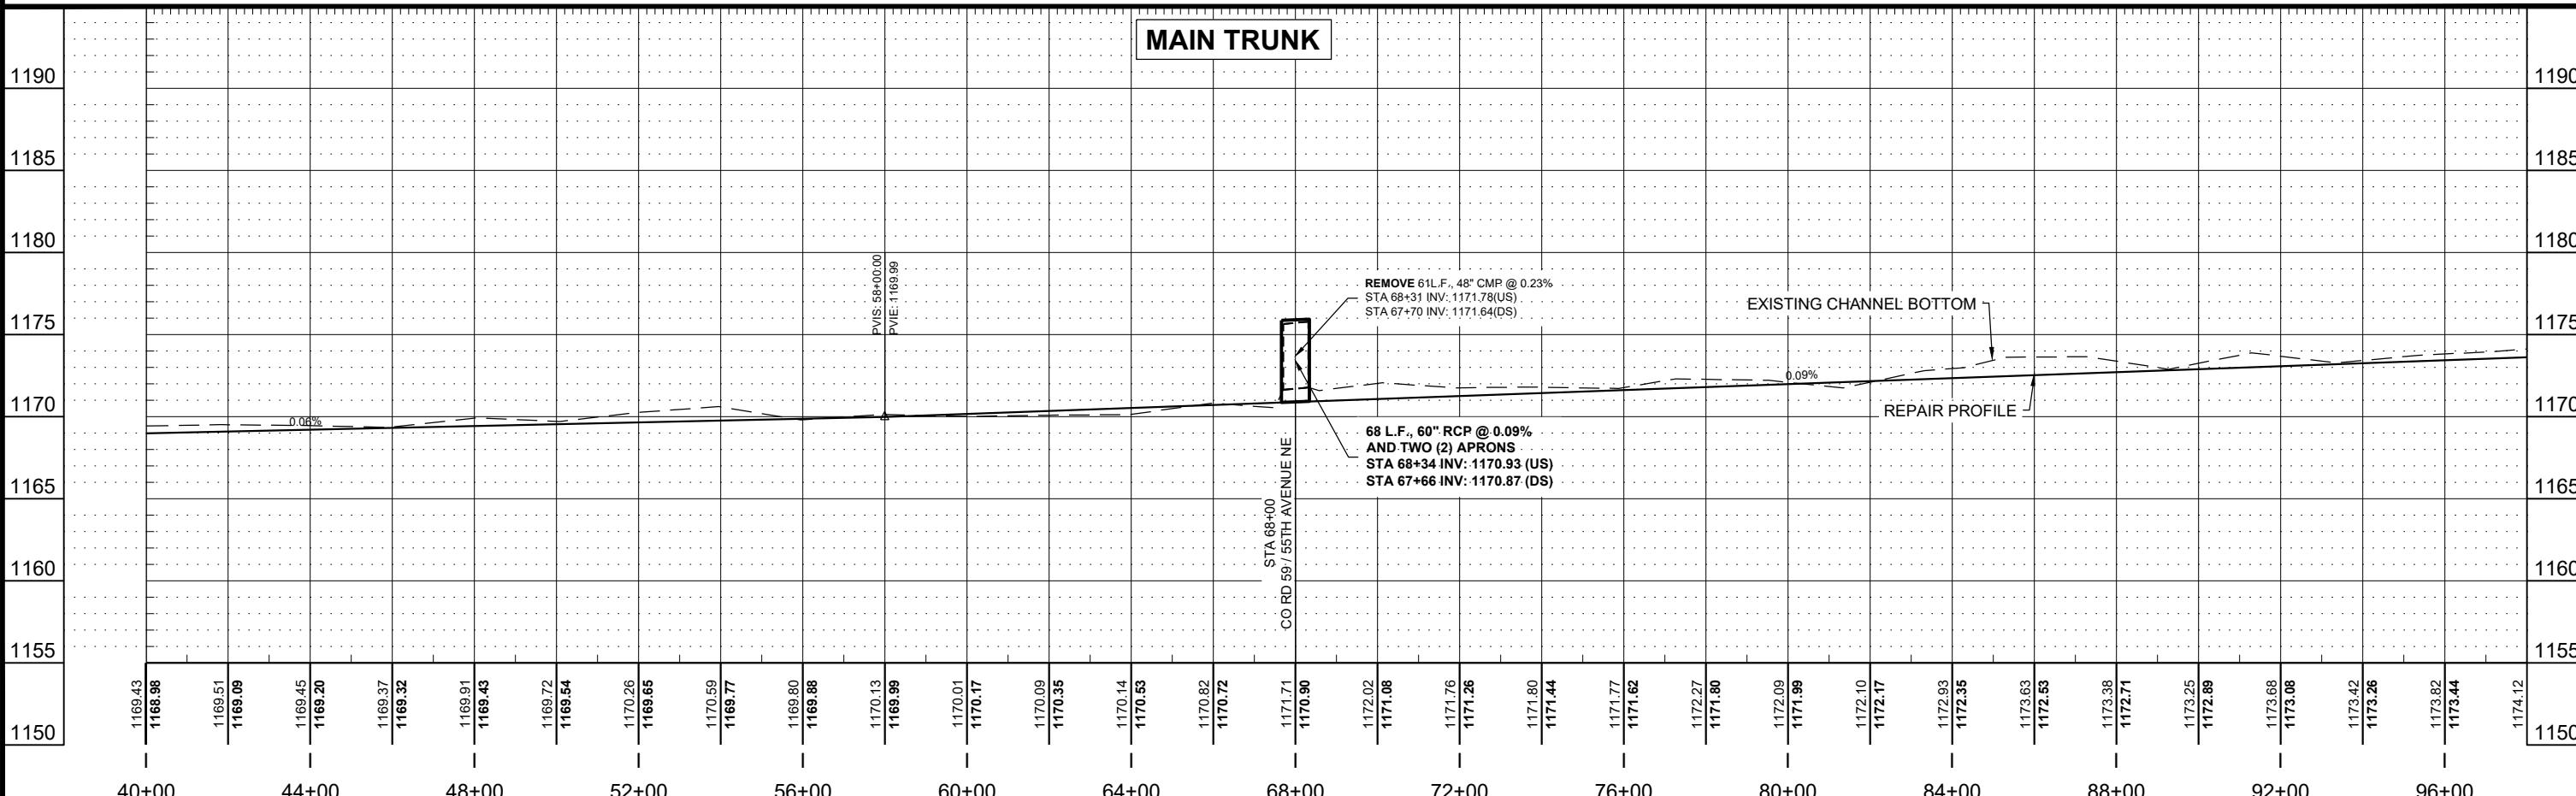
SHEET  
3 of 7

BENTON COUNTY DITCH 6  
STA. 40+00 - 96+00  
PROJECT NO. 6183-0001

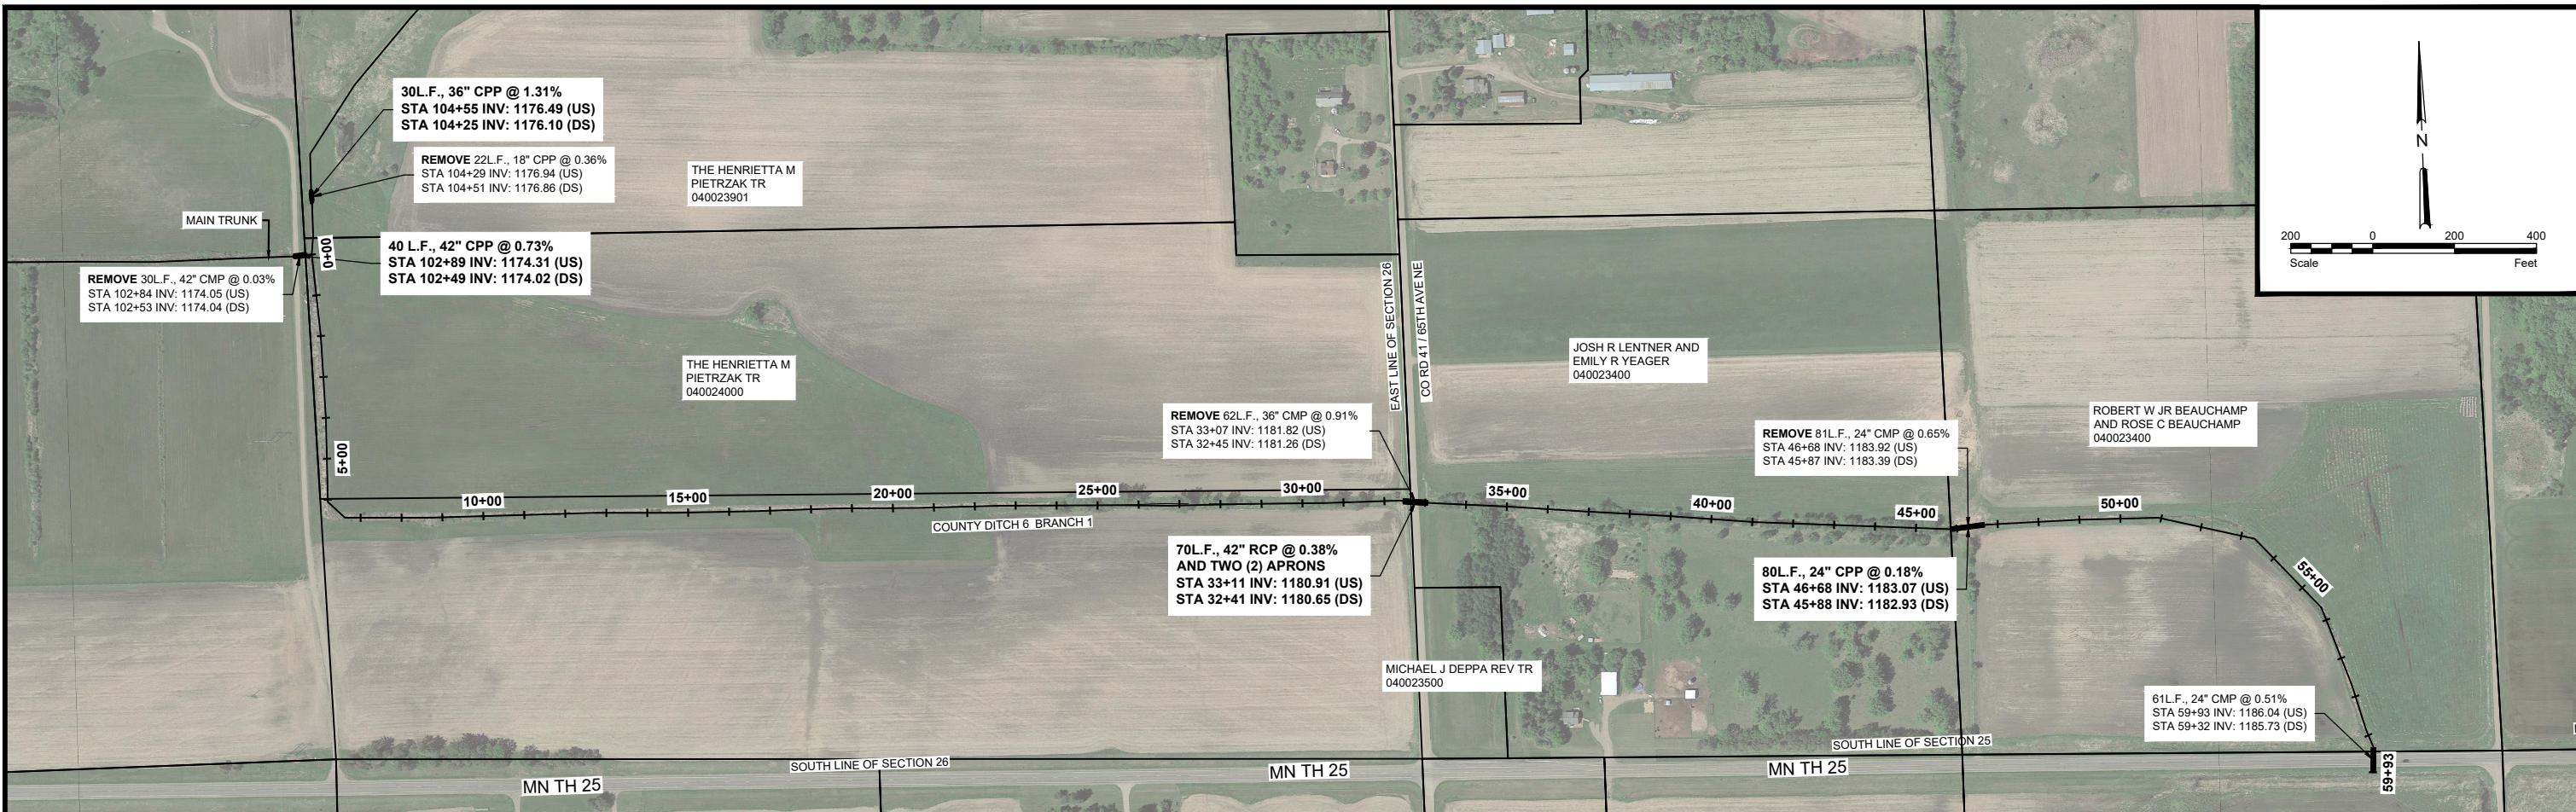
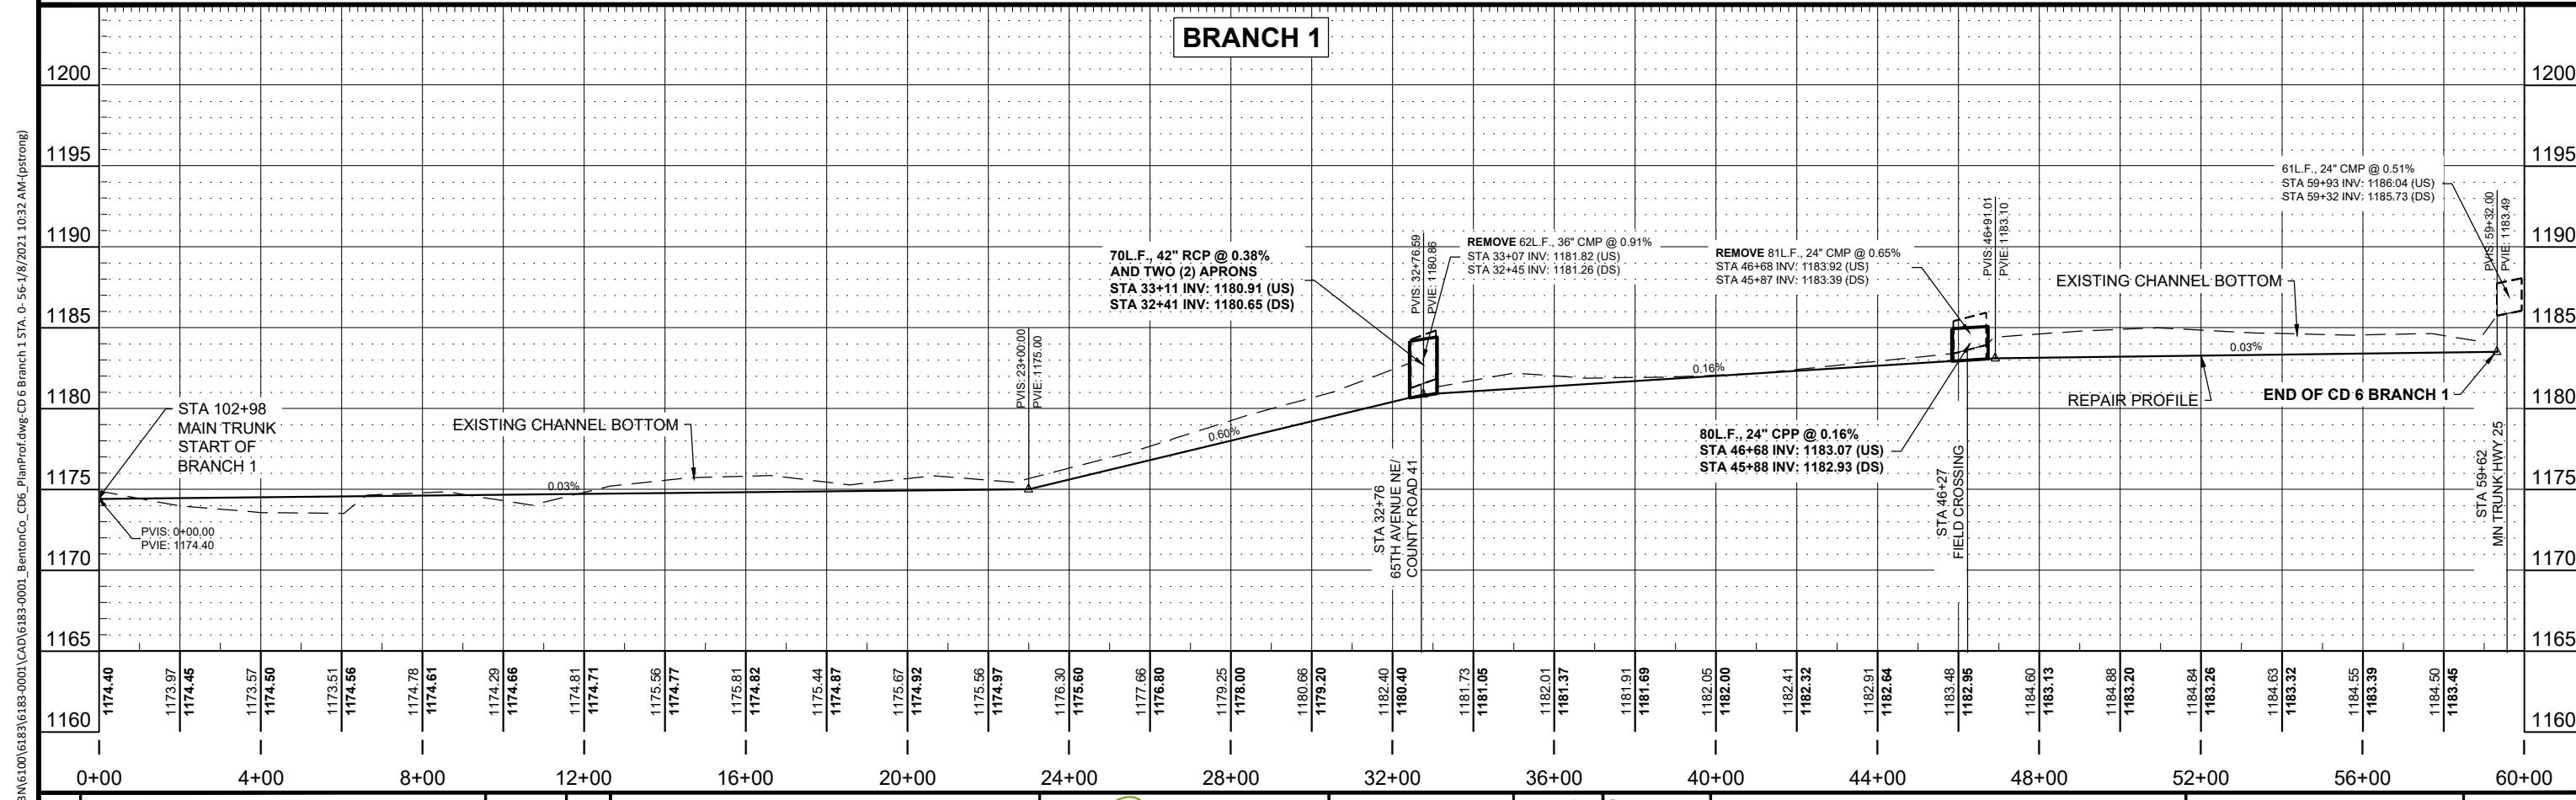
SHEET  
5 of 7

BENTON COUNTY DITCH 6  
STA. 0+00 - 56+00  
PROJECT NO. 6183-0001

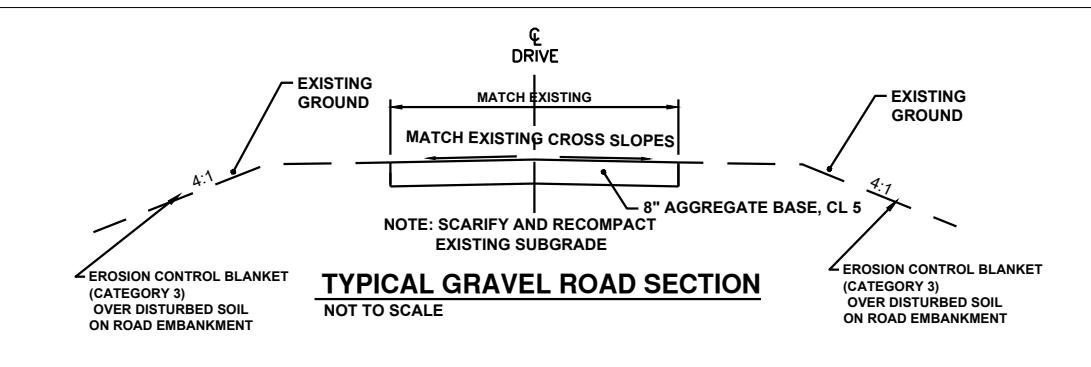
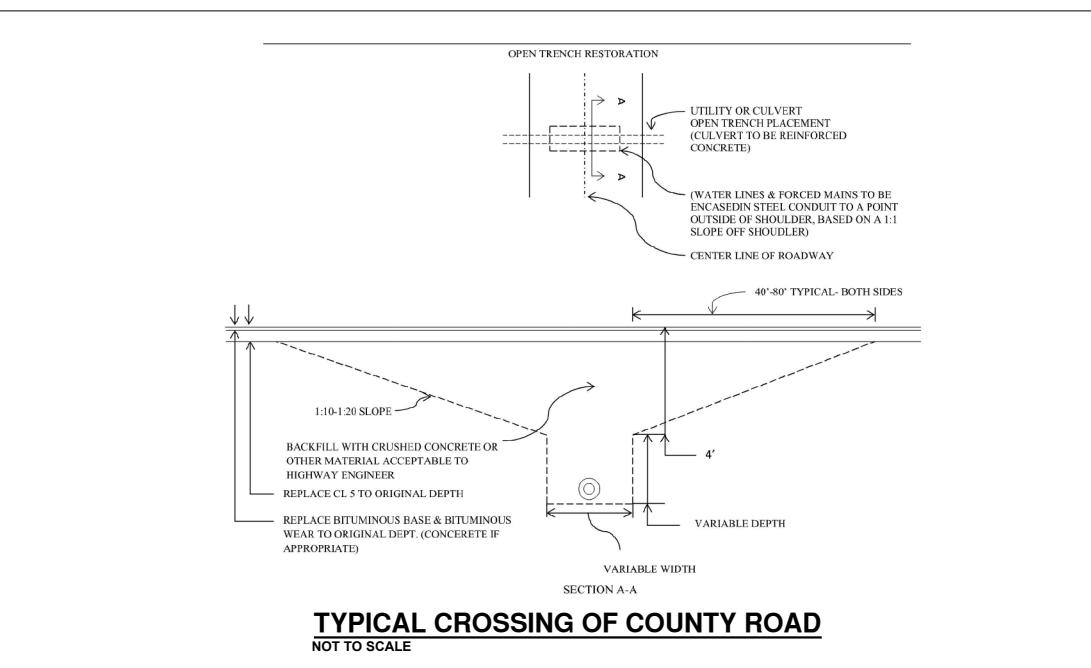
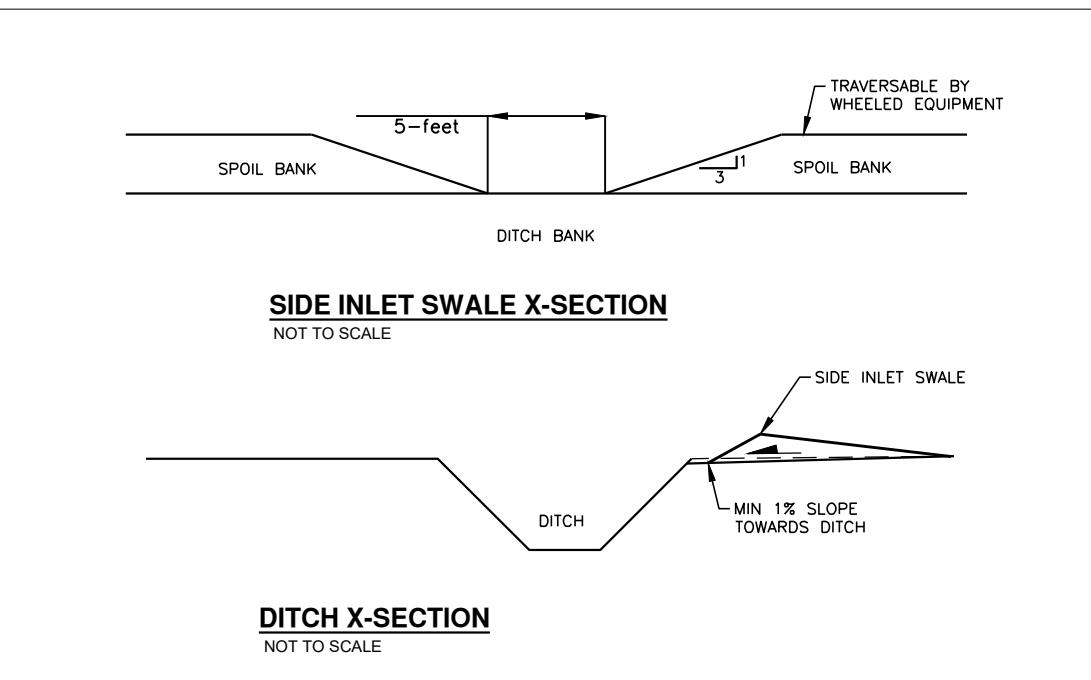
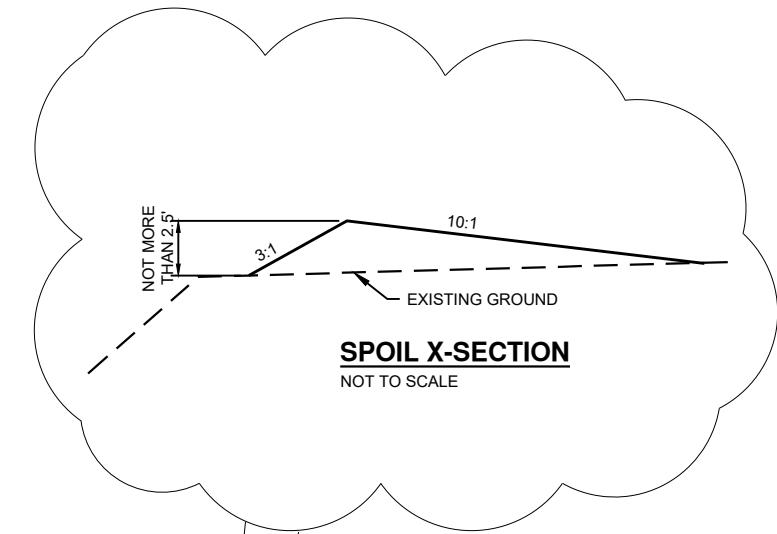
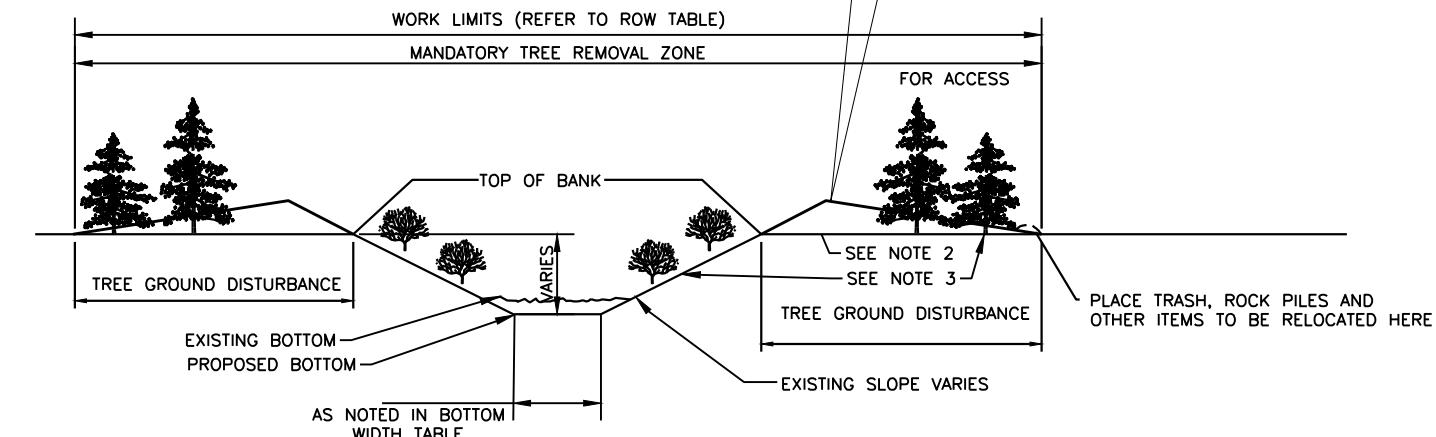
HOUSTON ENGINEERING INC.	Maple Grove	Drawn by PAS	Date 1-8-2021	BENTON COUNTY DITCH 6 REPAIR PLAN BENTON COUNTY GILMAN, MN	QUANTITIES & TABLES	SHEET 7 of 7

RIGHT-OF-WAY		
	STATION	ROW WIDTH (FT)*
MAIN TRUNK	0+00 to 6+00	60
	6+00 to 24+00	65
	24+00 to 36+00	70
	36+00 to 132+00	65
	132+00 to 142+00	70
	142+00 to 153+40	65
BRANCH 1	00+00 to 24+00	65
	24+00 to 27+00	70
	27+00 to 42+00	65
	42+00 to 46+00	70
	46+00 to 59+32	65

BOTTOM WIDTH TABLE			
	Start Station	End Station	Bottom Width (ft)
Main Trunk	0+00	109+50	4
Main Trunk	109+50	153+40	3
Branch 1	0+00	59+32	3
